**PURGATORY VILLAGE LAND, LLC  
WETLAND MITIGATION AND MONITORING REPORT  
AT THE OPHIR FEN**

2022 Monitoring Report  
Permit No. 200175166

Mitigation Project ID: SPK-20017516

*November 4, 2022*

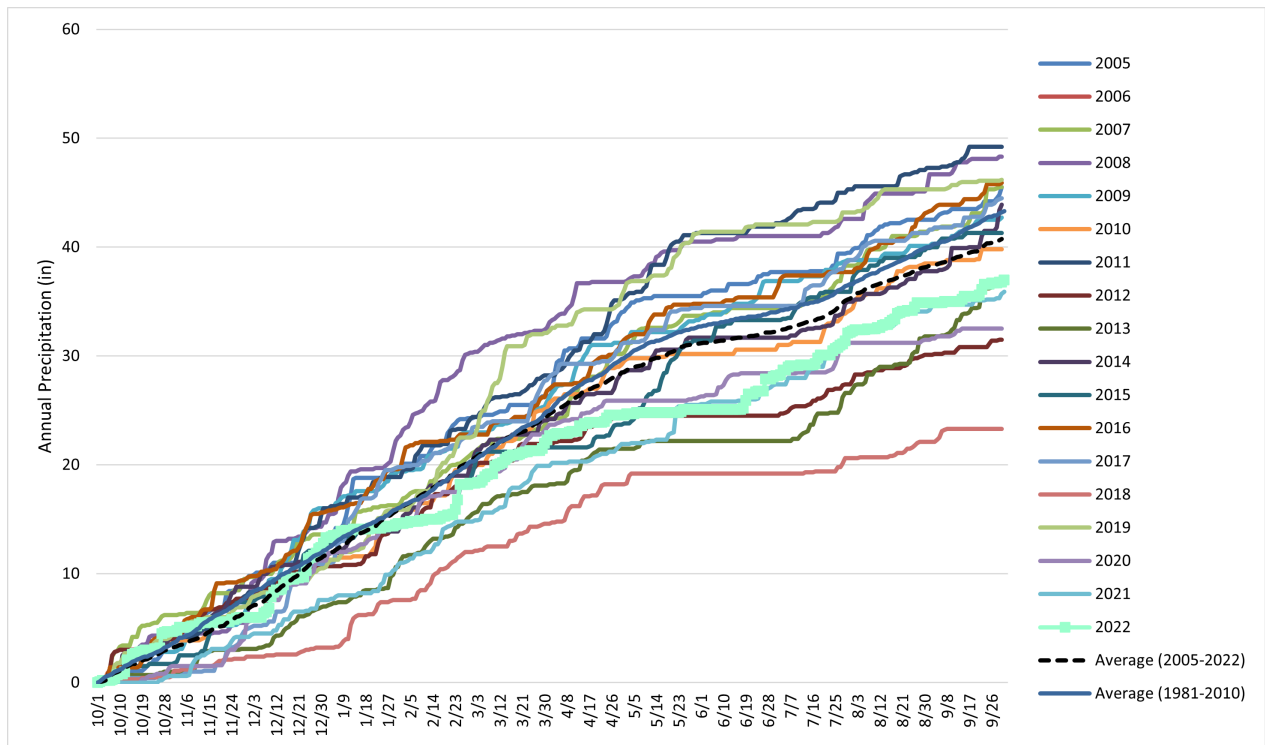
**Figure 1. Accumulated precipitation from SNOTEL site 713, Red Mountain Pass**

Accumulated precipitation in 2022’s water year (October 1st, 2021 – September 30th, 2022) was below average of the last 15 years (Figure 1), as reported at the nearest SNOTEL site 713- Red Mountain Pass (approximately 4.5 miles NNE of the Ophir site). Total accumulated precipitation for the 2022 water year totaled 37 inches, compared to an average of 40.9 inches from 2005-2021. Winter precipitation was slightly below average for the San Juan’s, but a warm and dry spring coupled with dust on snow events led the snowpack to completely melt off about three weeks before the average date of zero Snow Water Equivalent. A slightly above average monsoon season started in mid-June and delivered consistent and strong precipitation pulses through September, which helped to increase precipitation totals after the dramatic snow melt runoff in the spring. Peak flow in the Animas River also occurred about three weeks before the 1898 – 2021 median peak date and the peak flow was about 3,000 CFS in Durango in 2022. The Red Mountain Pass precipitation data are used to estimate the precipitation that may have fallen on site, with the understanding that due to high spatial variability in precipitation in the San Juan Mountains it serves as an approximation for the actual moisture at the Ophir site.

*The figure shows the water years 2009-2022 with average accumulated precipitation calculated from 2005-2022*

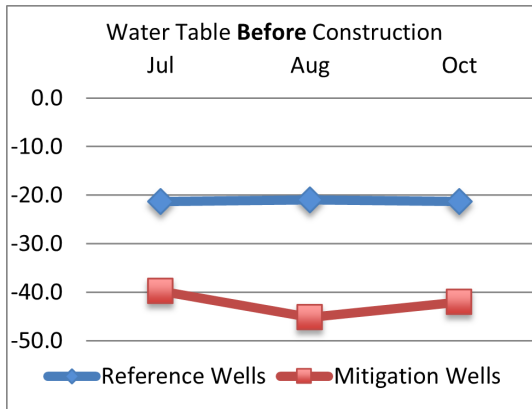
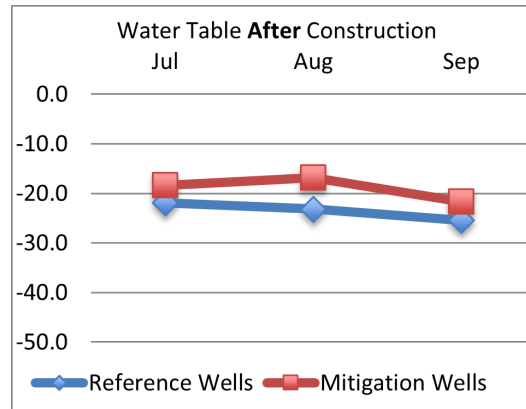
**Figures 2A-2B. Comparison of average water table depths before and after construction**

Using the Hydrologic Success Criteria, 100% of the mitigation wells were compliant in 2022 (Table 2, Figures 2A-2B, 3). Most wells showed a higher groundwater table (shallower depths) in 2022 than in 2021, especially in later in the season after the influence of the monsoon. This strong monsoon season produced large amounts of precipitation June – September, especially compared to recent years where the wells were dry (i.e. wells A5 and 8-0 in 2020). Reference well 2-0 was replaced in 2020, so the data only represents two water-years' worth of data. Using this hydrologic

*The graphs show the average water table depths (cm) for reference (1-0 and 2-0) and mitigation (6-0 and 12-0) wells for each month before and after construction. The points represent the average of all data from months during all the years of data before (2008-2012) or after construction (2012-2022).*

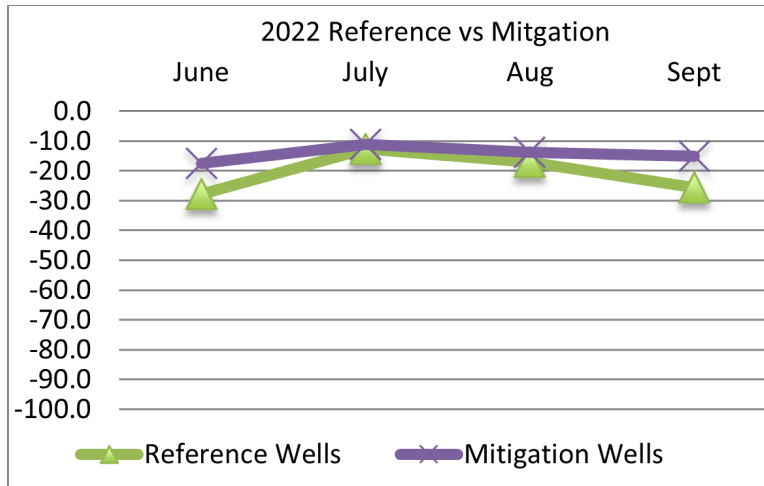
**Figure 3. Comparison of 2022 mitigation vs reference wells**

success level all wells meet the success criteria. The negative value of the difference between wells shows that the mitigation wells' average water table is higher than that of the reference wells (Figure 3 and Appendix B, Table B-1). Additionally, on two different occasions, large amounts of excelsior were distributed throughout the fen for water retention and erosion control. The "Crystal Fire" started at the base of the steepest part of the sloping fen on September 16<sup>th</sup>, 2021, and many of the excelsior bales were burned, jute mesh was installed across the slope on the volunteer event that had already been planned for September 25, 2021. The well known as "Plot 3" was destroyed in the fire. During this year's monsoon season, the jute mesh helped to minimize erosion. However, runnel formation and sediment/peat transportation was observed after large storm events. To prevent further erosion, excelsior bails and waddles were strategically placed throughout the slope and in channelized areas. Continued efforts to control erosion and promote revegetation will be needed to promote sheet flow and retention of water. In the coming years more data will indicate whether the sloping area of the fen is retaining water and promoting sedge growth. In its current state, the wells on the sloping part of the fen have not shown great improvement aside from normal monsoonal fluctuations of water table depth.

The large bare area’s hydrology is best measured with the A-1 to A-7 wells installed after construction in 2012 and the 7-0 and 8-0 wells directly below the large bare area. No wells existed within the large bare area prior to construction; hence, the water table data is interpreted to be at a level hospitable to wetland species (i.e., 30 cm below the surface or less) instead of levels prior to construction. The 2022 data show only two of the nine wells have an average water table below 30 cm (Appendix B, Table B-2). Dam 1, 2, and 3 were removed from Table B-2 as they have not been monitored since 2016 due to damage by rodents. We have observed that most of the wells, referenced here, have met or exceeded the 30 cm standard every year since 2012, with the exception of 2018 and 2020, which were very dry years. The 2022 data shows improvements in water depths, likely due to the precipitation during monsoon season, as shown by several wells that had greater water depths in 2022, but were dry in 2021 (Figure 3).

The graph shows the water table depths (cm) for reference (1-0 and 2-0) and mitigation (6-0 and 12-0) wells for each monthly monitoring event in 2022.
