What are the implications for water resource management?

Tree rings and drought in the Animas basin

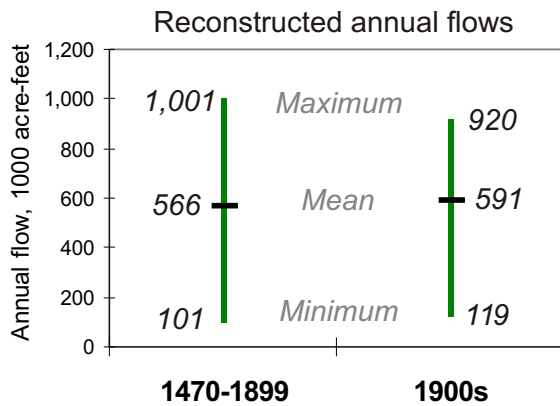
The range of variability of Animas flow over the four centuries prior to 1900 was broader than what was seen in the past century, and flows were lower on average before 1900 (*figure below*). In addition to more extreme flows, the record of past flows included several droughts longer than 2000-2004 (*bottom figure*).

While the conditions of the past will not be exactly repeated in the future, they can provide a guide to the full range of conditions that might be expected--including droughts longer and more severe than 2000-2004.

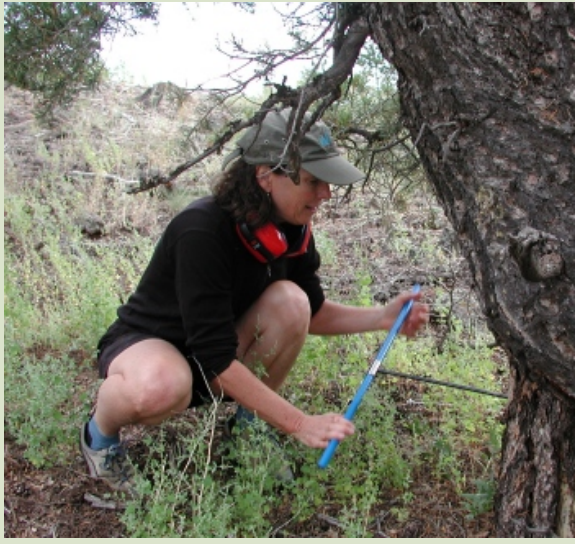
1977

1983

Annual growth rings from a Douglas-fir in the South San Juan Mts. include a drought year (1977) and a very wet year (1983).

Tree growth in dry climates is limited by water availability. So trees growing at lower elevations in Colorado (pinyon pine, ponderosa pine, and Douglas-fir) faithfully record the changes in precipitation from year to year (*image below*).
