Locations downstream of 416 Fire:

Hermosa Creek above CR 203 benthic community composition pre- and post-fire

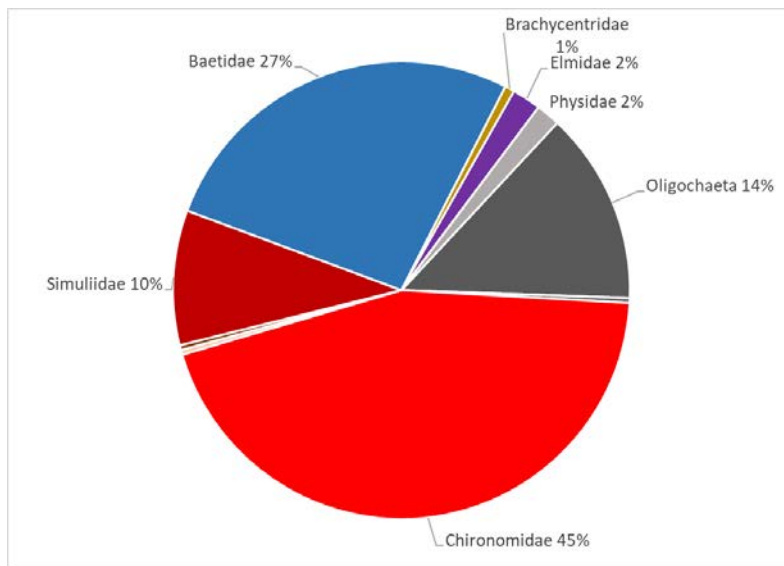
2018
Post-fire

Animas River at Trimble Lane benthic community composition pre- and post-fire

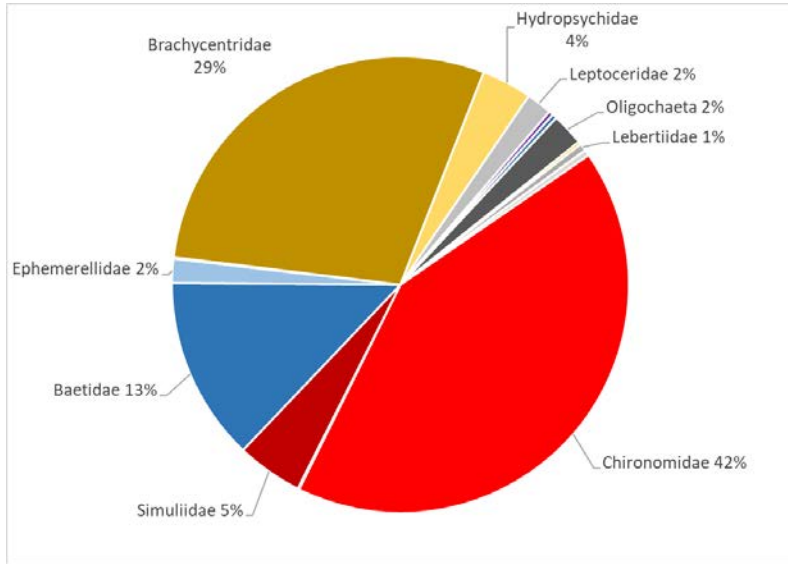
Pre-fire

Animas River at 32nd St benthic community composition pre- and post-fire

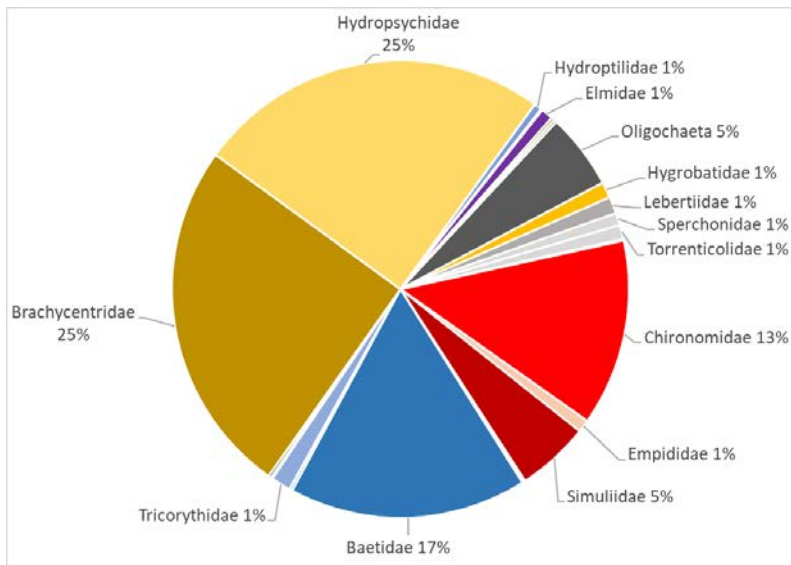
Pre-fire

Animas River above Lightner Creek benthic community composition pre- and post-fire

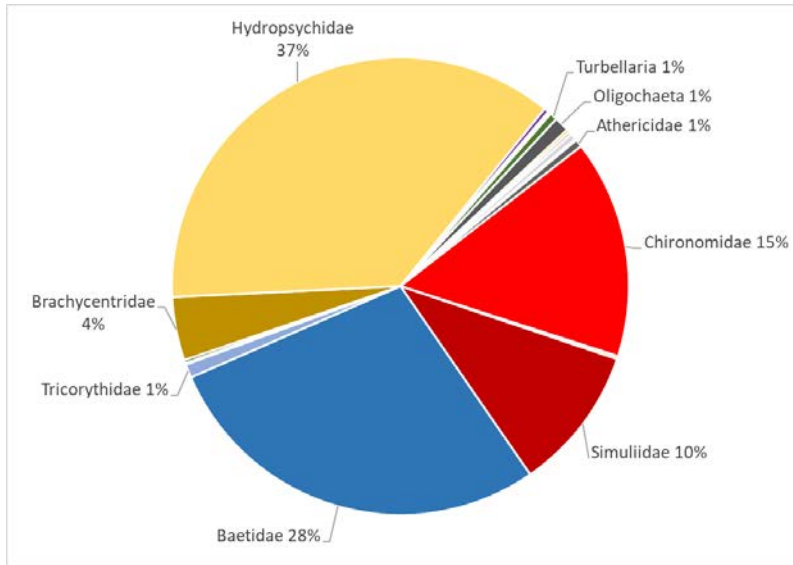
Pre-fire

Animas River at Purple Cliffs benthic community composition pre- and post-fire

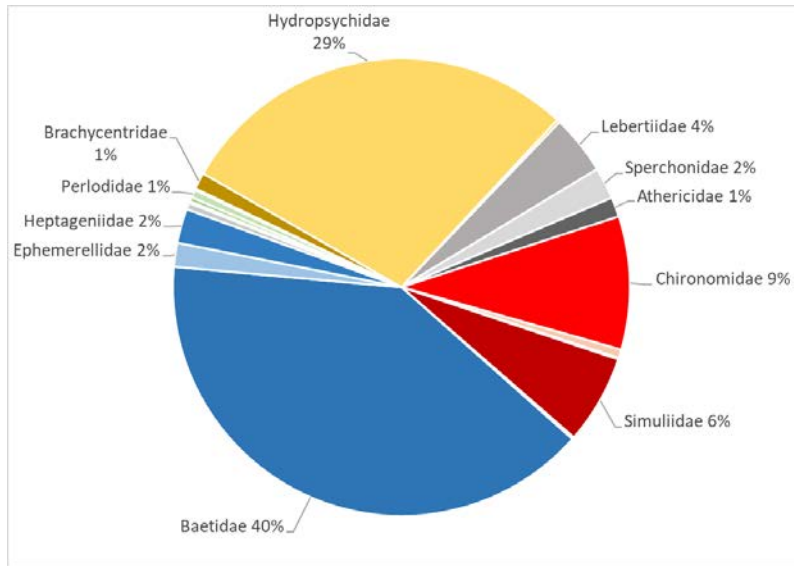
Pre-fire

Animas River at Bakers Bridge benthic community composition pre- and post-fire

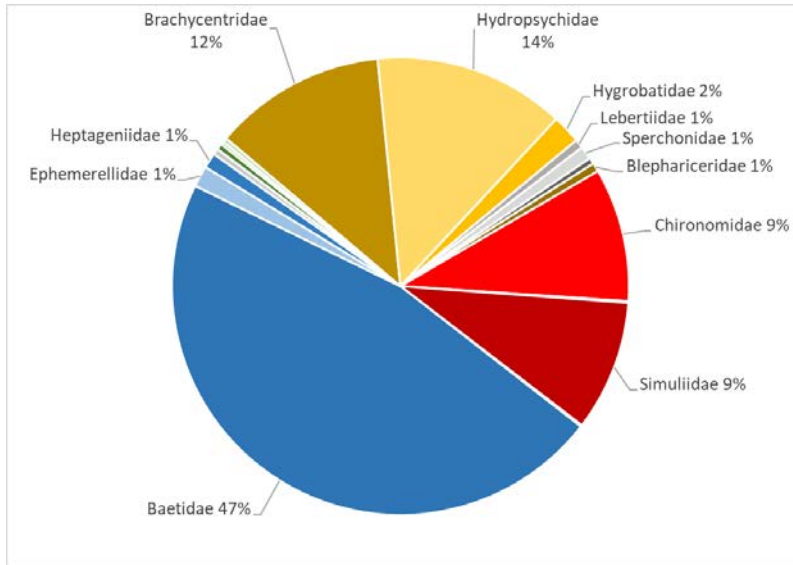
Pre-fire

Animas River at James Ranch benthic community composition pre- and post-fire

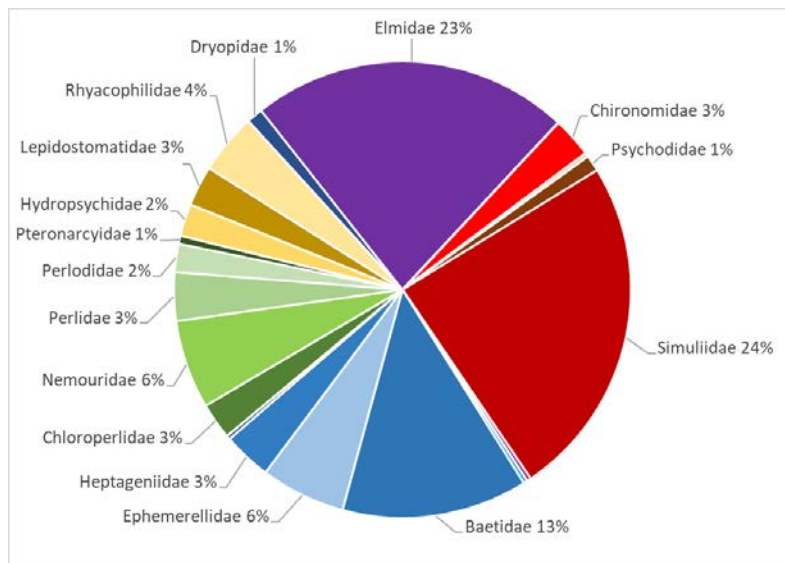
2019
Post-fire

Junction Creek at Colorado Trailhead benthic community composition pre- and post-fire
