Summary of 2016 Animas River Water Quality Monitoring at Rotary Park in Durango, CO

Monitoring Program Overview

Appendix A:

Appendix B:

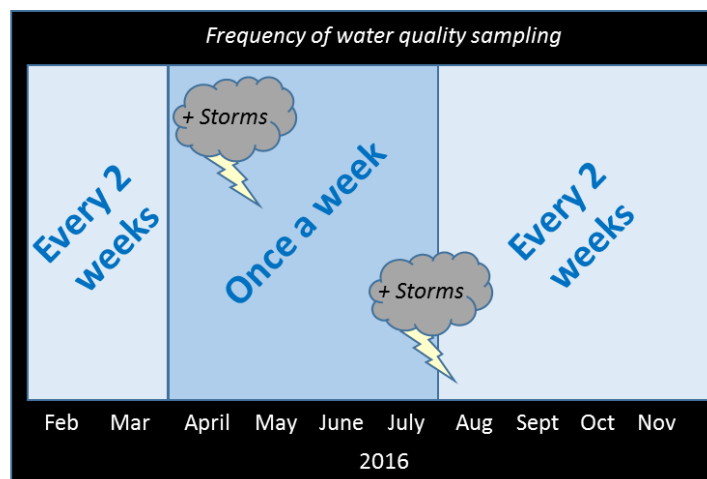
Figure 1: Water quality sampling frequency

MSI collected grab samples from the Animas River at Rotary Park at weekly intervals during peak river recreation season, and every other week in February, March, August, September, October, and November (Figure 1). Samples were analyzed by Green Analytical laboratory in Durango, CO, for total and dissolved concentrations of aluminum, arsenic, copper, iron, manganese, lead, selenium, and zinc.

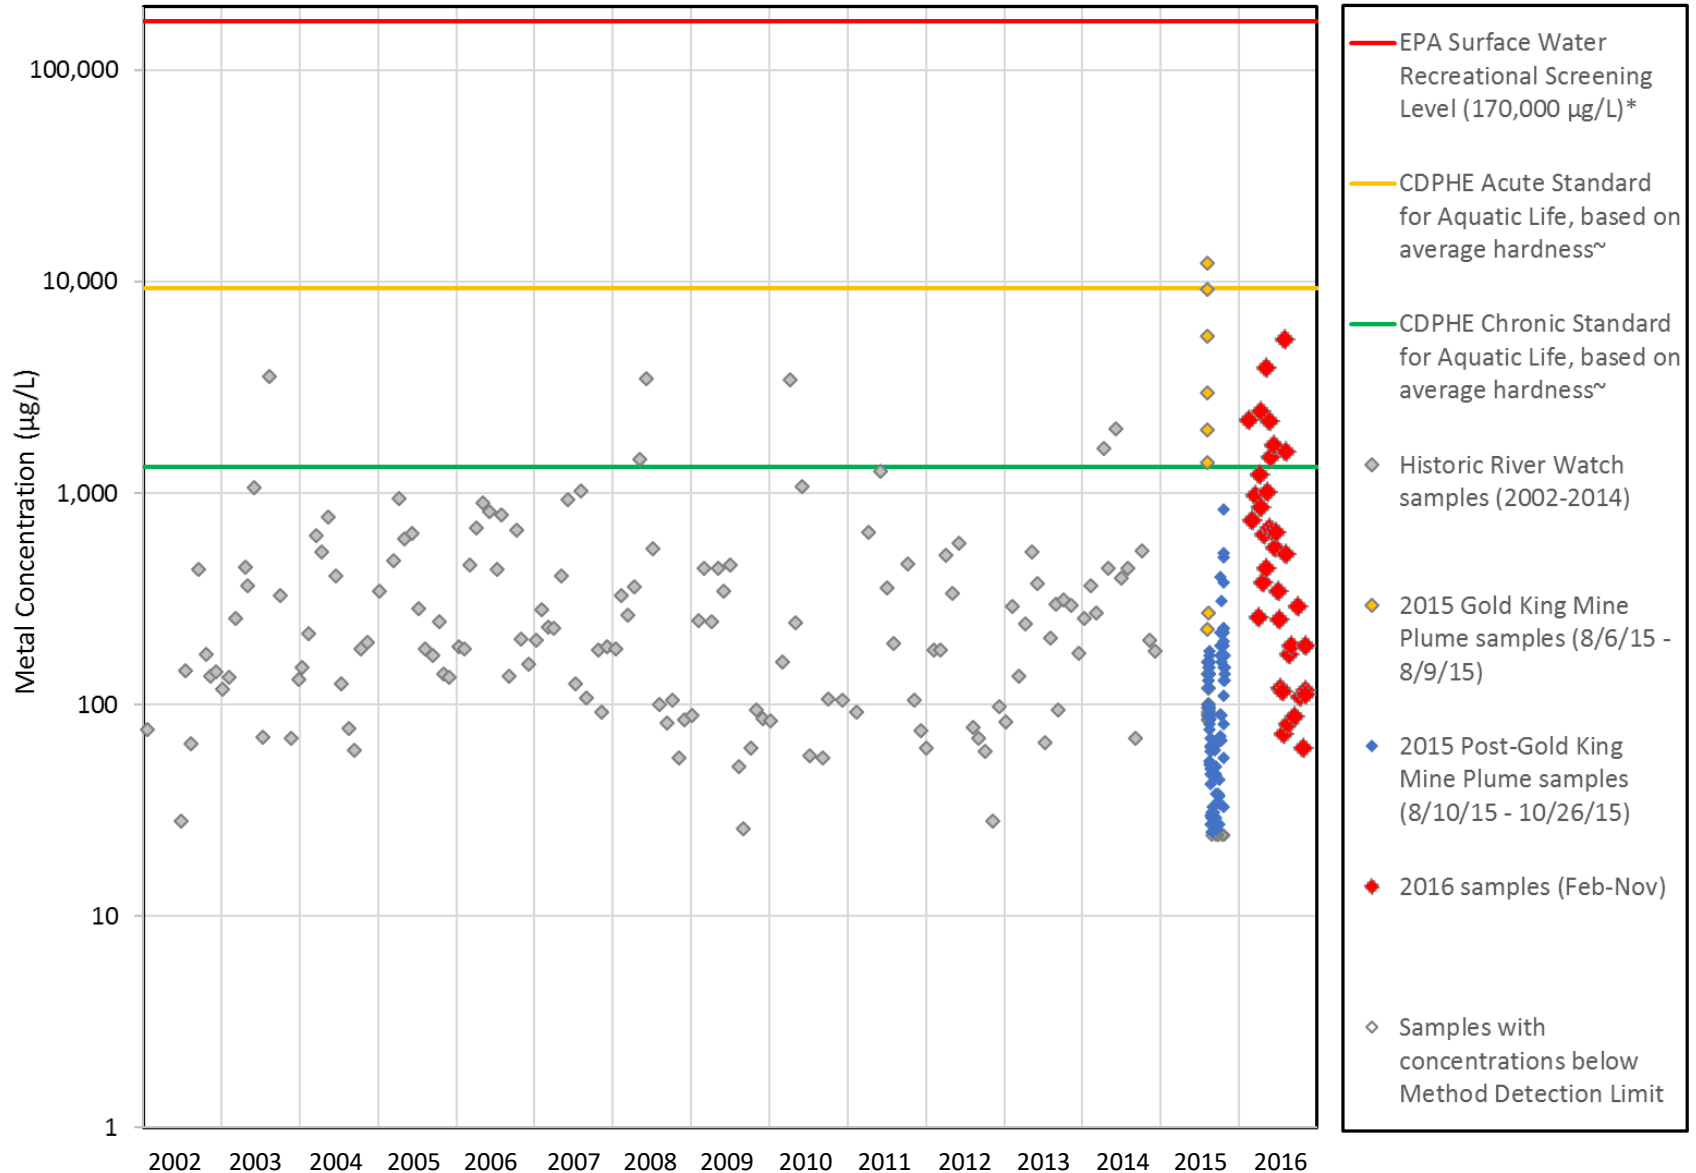
Total Aluminum, Animas River at Durango, CO: 2002-2016

* The recreational screening level represents the level at which no adverse health effects are expected to occur in humans consuming 2L of water per day, from the Animas, orally, for 64 days each year for a total of 30 years.

~Colorado Department of Public Health and the Environment (CDPHE) standards based on Colorado surface water quality classifications and Reg. 31 and 34. Standards vary with water hardness and are plotted here using an average water hardness of the Animas River at this location, 208 mg/L.

Note: 2002 - 2014 data is River Watch data from the Animas River at the fish hatchery in Durango, CO. 2015 and 2016 data is Mountain Studies Institute data from the Animas River at Rotary Park in Durango, CO

- Aluminum was close to surpassing the CDPHE chronic water quality standard for aquatic life (aluminum surpassed the chronic water quality standard based on average hardness, but did not surpass the chronic water quality standard based on paired metal-hardness values).

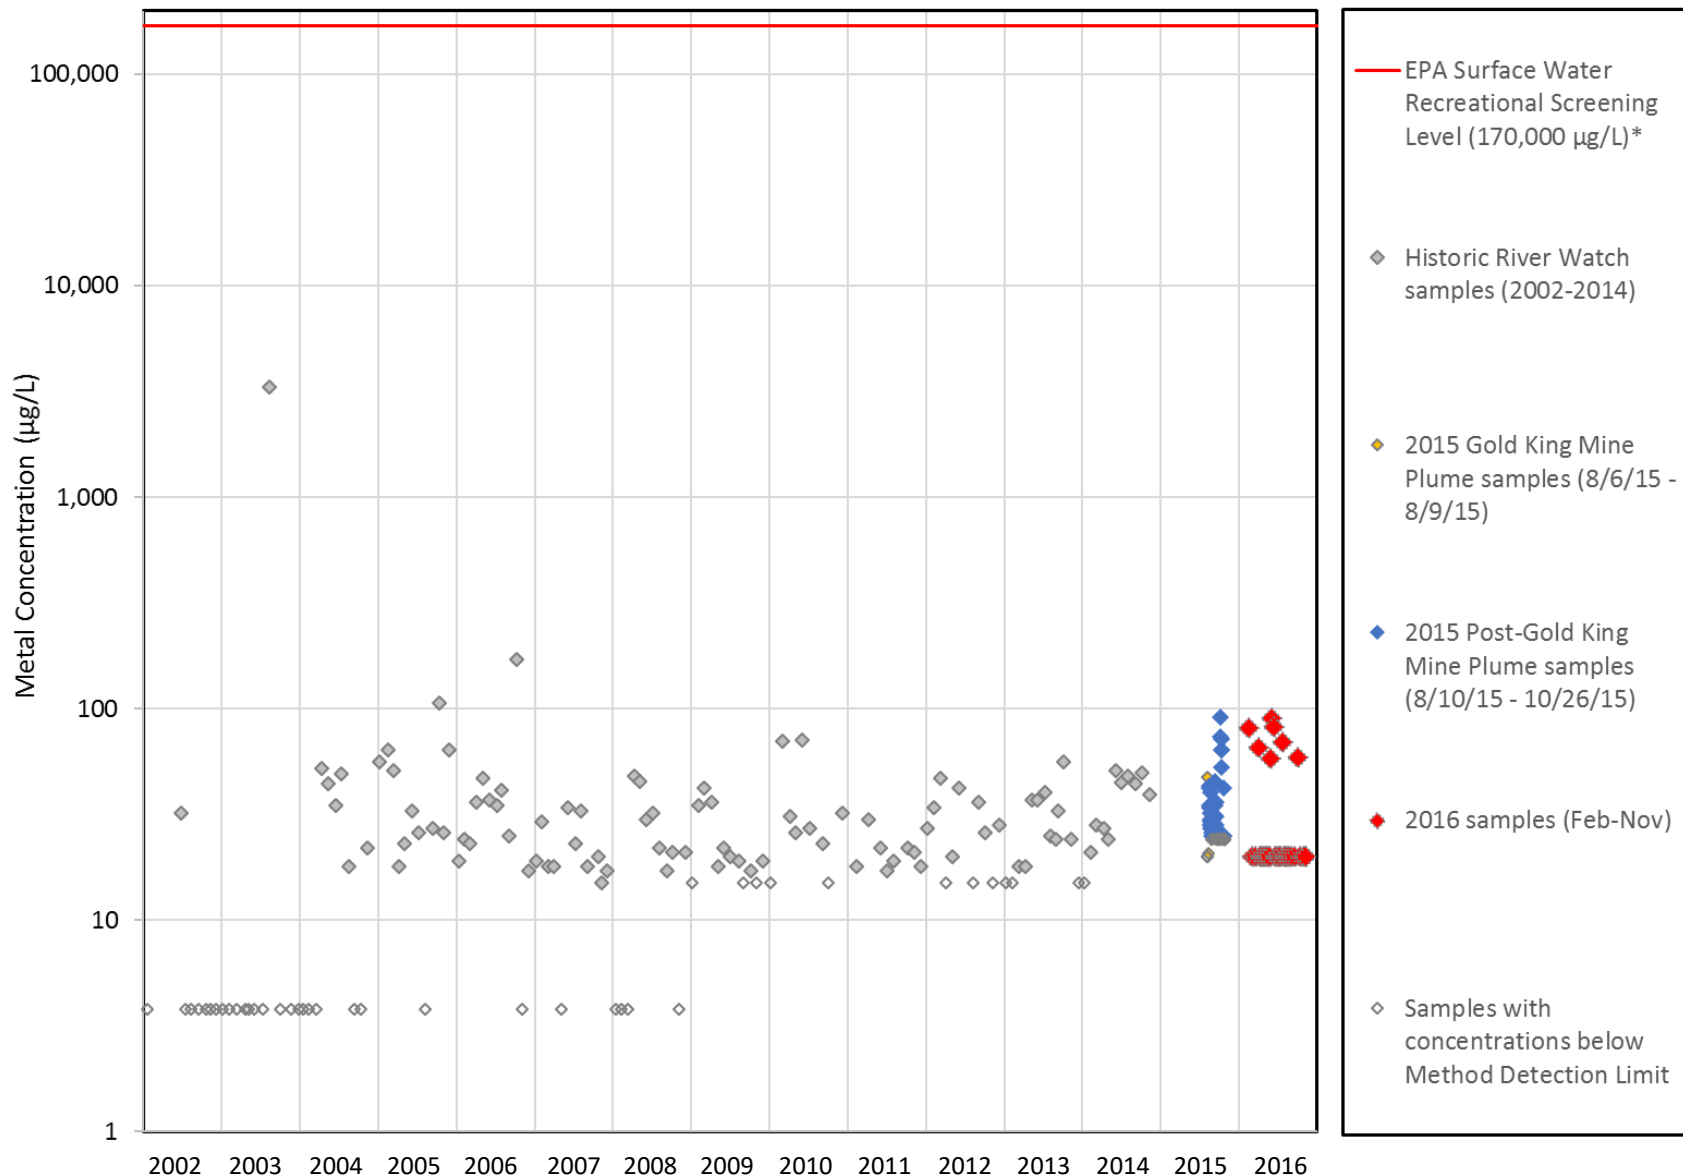
Dissolved Aluminum, Animas River at Durango, CO: 2002-2016

* The recreational screening level represents the level at which no adverse health effects are expected to occur in humans consuming 2L of water per day, from the Animas, orally, for 64 days each year for a total of 30 years.

Note: 2002 - 2014 data is River Watch data from the Animas River at the fish hatchery in Durango, CO. 2015 and 2016 data is Mountain Studies Institute data from the Animas River at Rotary Park in Durango, CO.

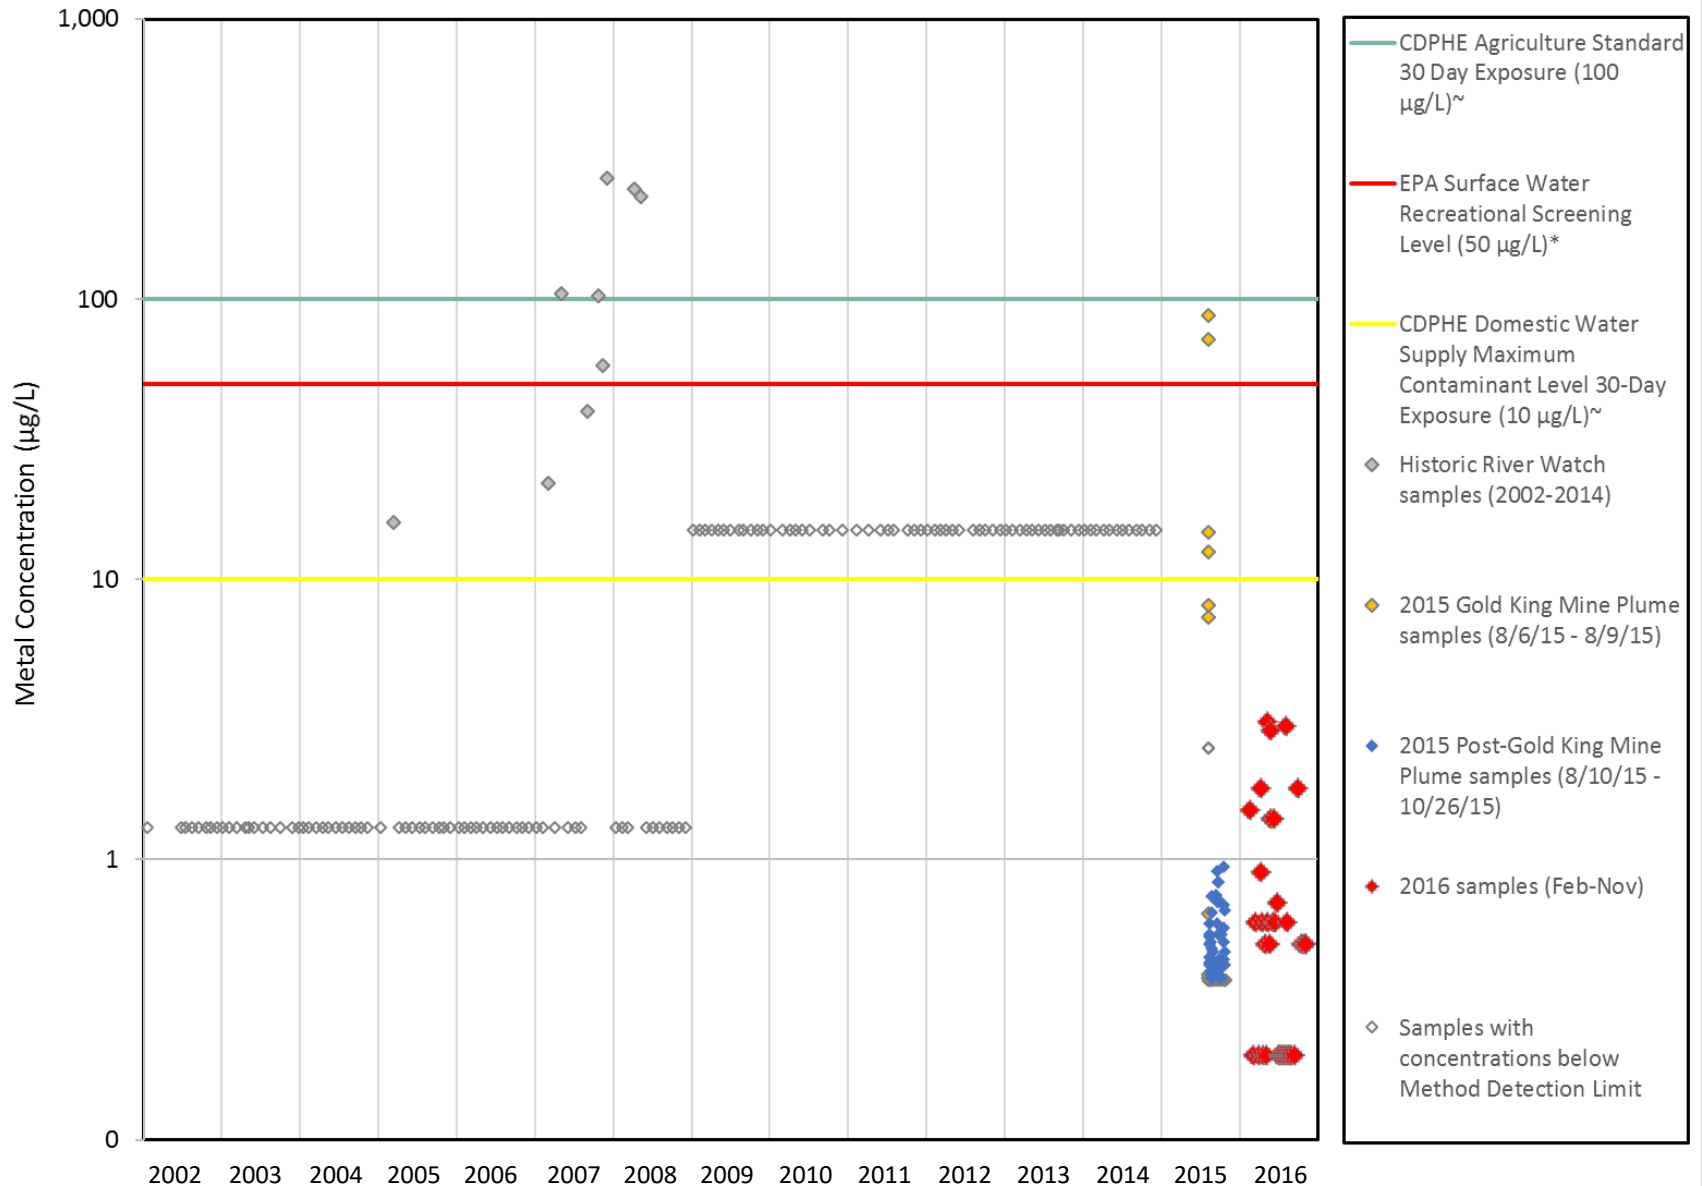
Total Arsenic, Animas River at Durango, CO: 2002-2016

^{*} The recreational screening level represents the level at which no adverse health effects are expected to occur in humans consuming 2L of water per day, from the Animas, orally, for 64 days each year for a total of 30 years

[~]Colorado Department of Public Health and the Environment (CDPHE) standards based on Colorado surface water quality classifications and Reg. 31 and 34.

Note: 2002 - 2014 data is River Watch data from the Animas River at the fish hatchery in Durango, CO. 2015 and 2016 data is Mountain Studies Institute data from the Animas River at Rotary Park in Durango, CO

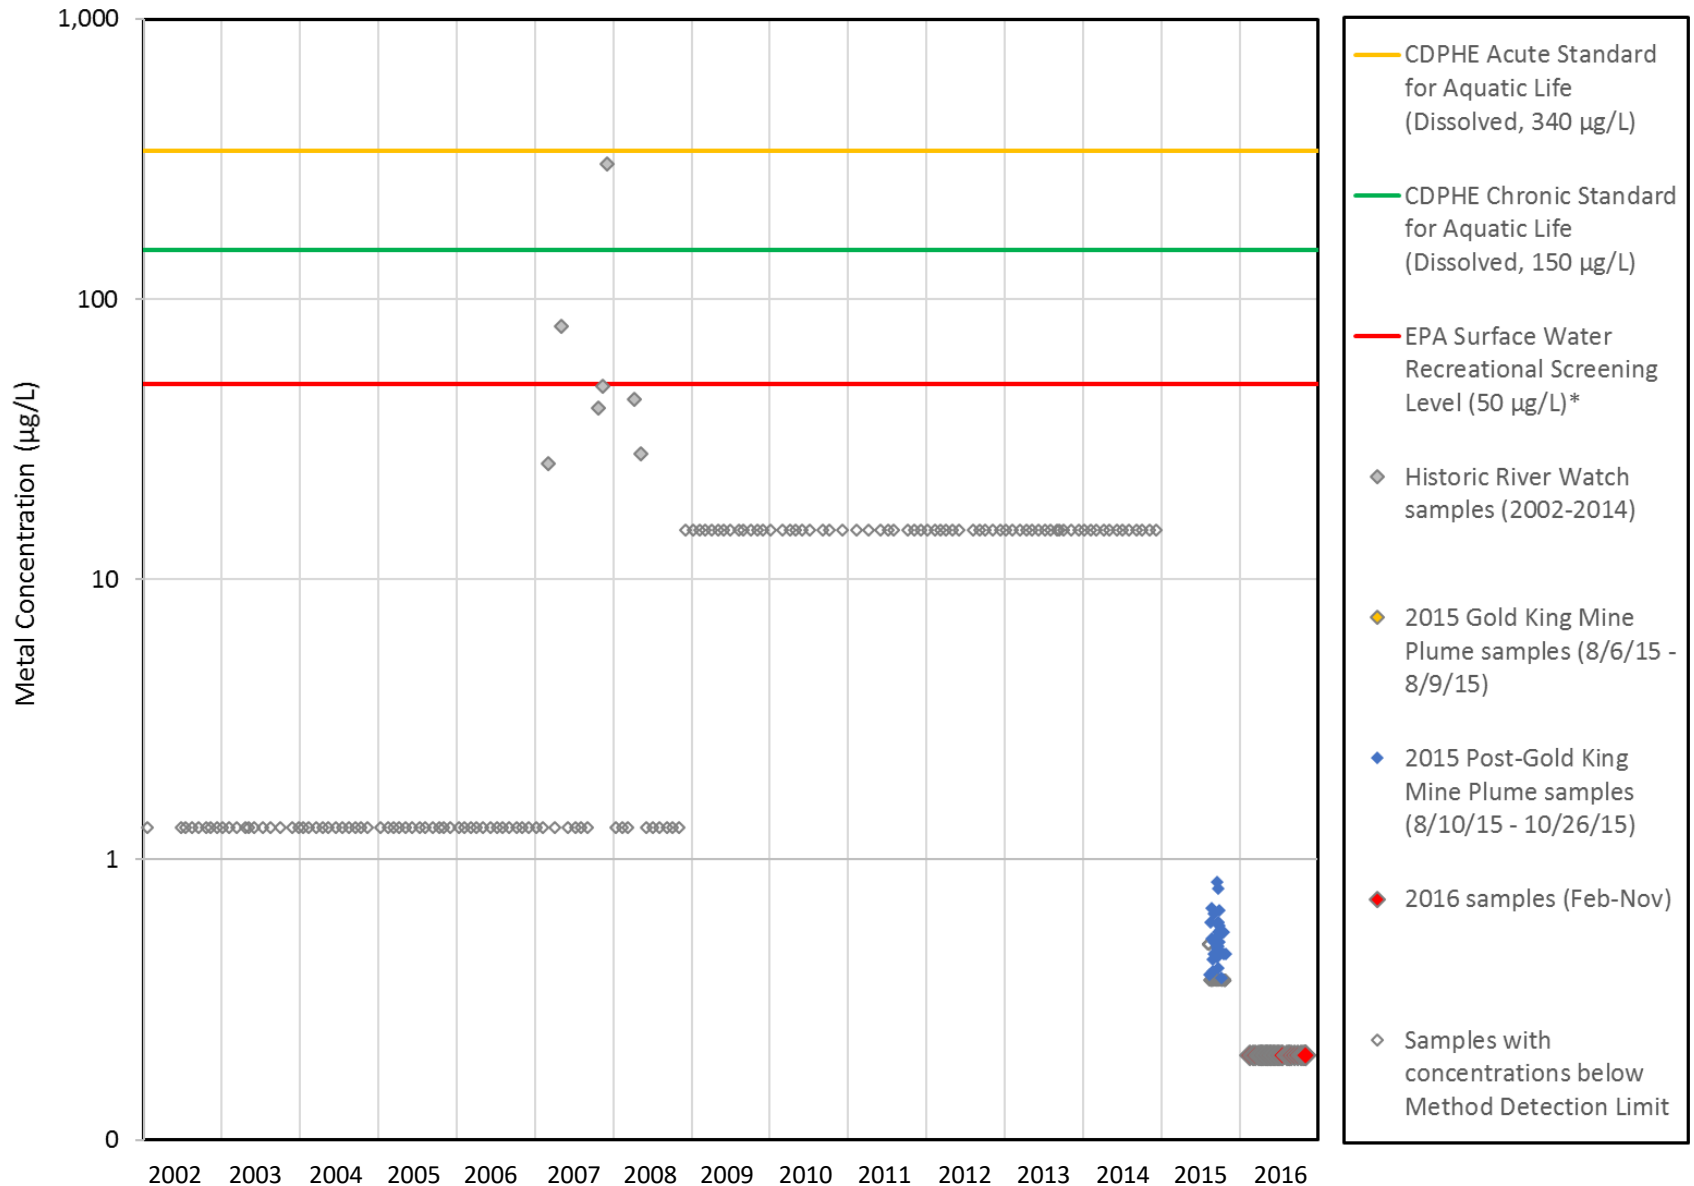
Dissolved Arsenic, Animas River at Durango, CO: 2002-2016

* The recreational screening level represents the level at which no adverse health effects are expected to occur in humans consuming 2L of filtered water per day, from the Animas, orally, for 64 days each year for a total of 30 years.

Note: 2002 - 2014 data is River Watch data from the Animas River at the fish hatchery in Durango, CO. 2015 and 2016 data is Mountain Studies Institute data from the Animas River at Rotary Park in Durango, CO.

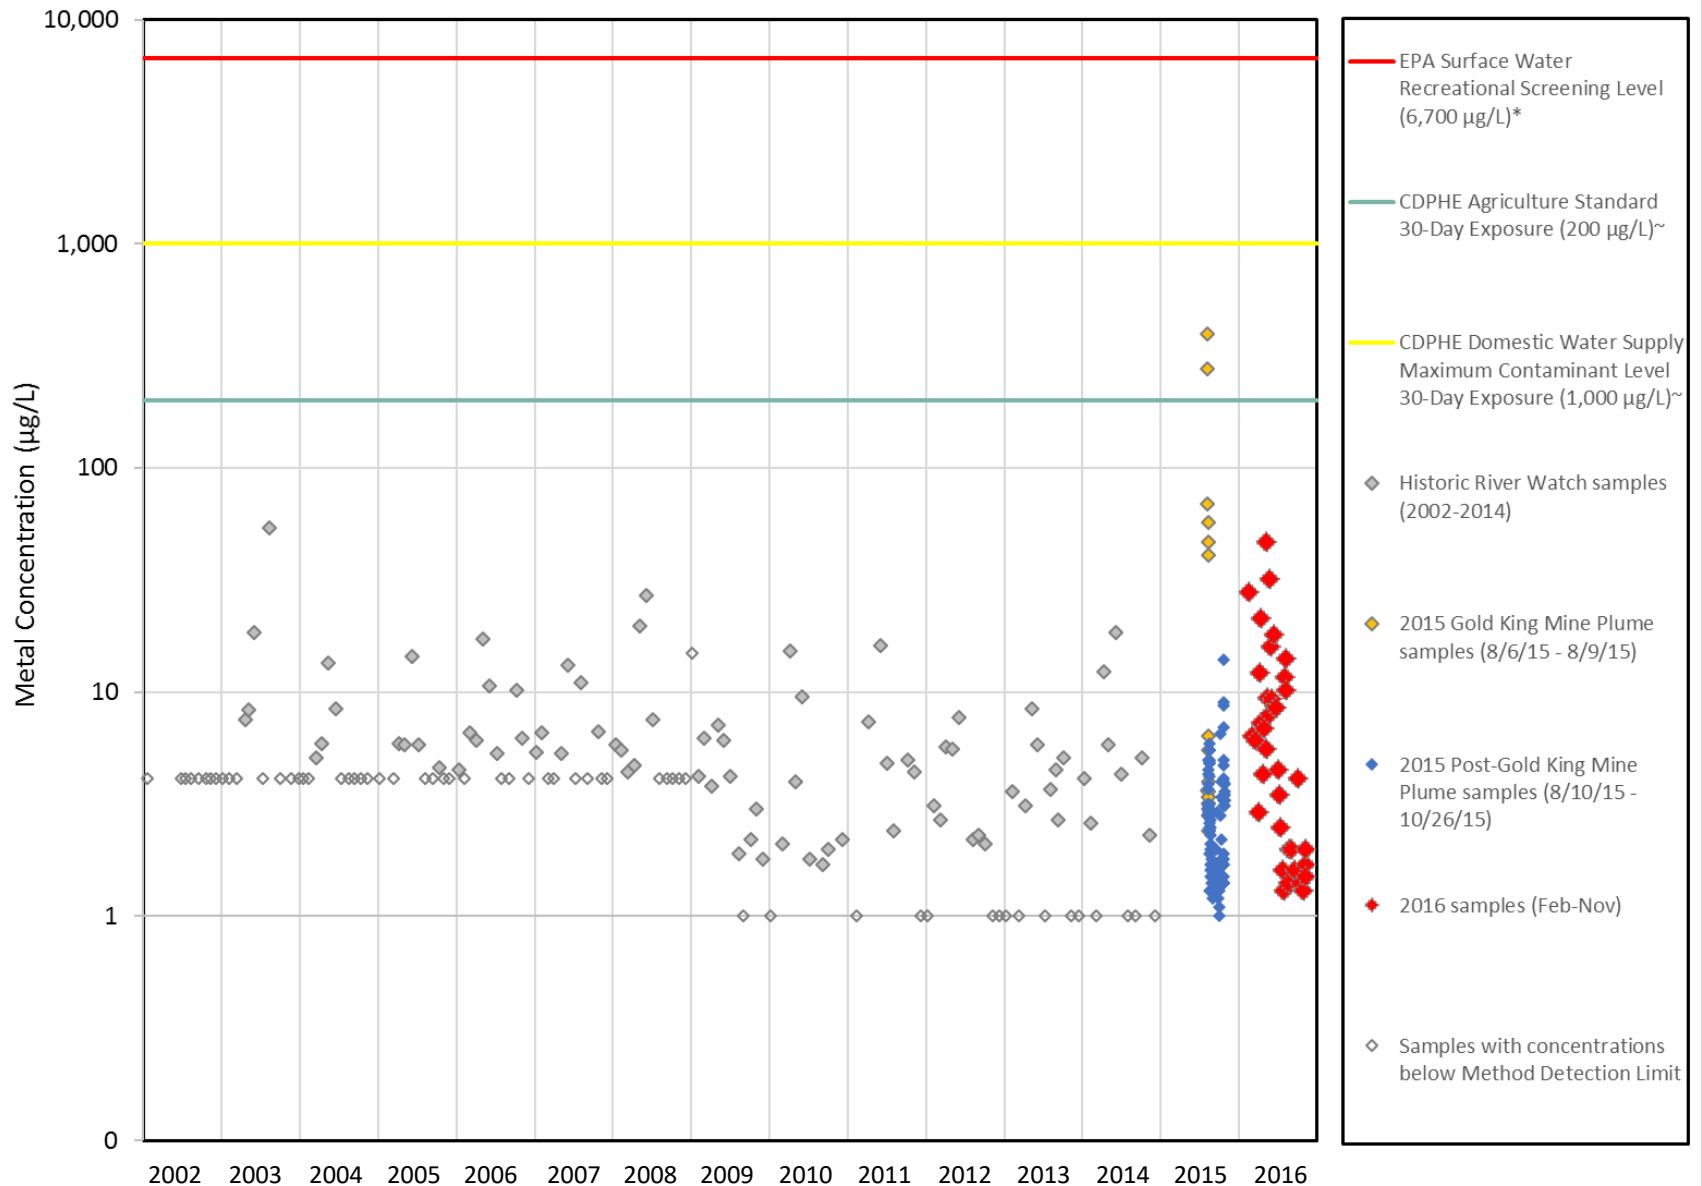
Total Copper, Animas River at Durango, CO: 2002-2016

* The recreational screening level represents the level at which no adverse health effects are expected to occur in humans consuming 2L of water per day, from the Animas, orally, for 64 days each year for a total of 30 years.

~Colorado Department of Public Health and the Environment (CDPHE) standards based on Colorado surface water quality classifications and Reg. 31 and 34.

Note: 2002 - 2014 data is River Watch data from the Animas River at the fish hatchery in Durango, CO. 2015 and 2016 data is Mountain Studies Institute data from the Animas River at Rotary Park in Durango, CO

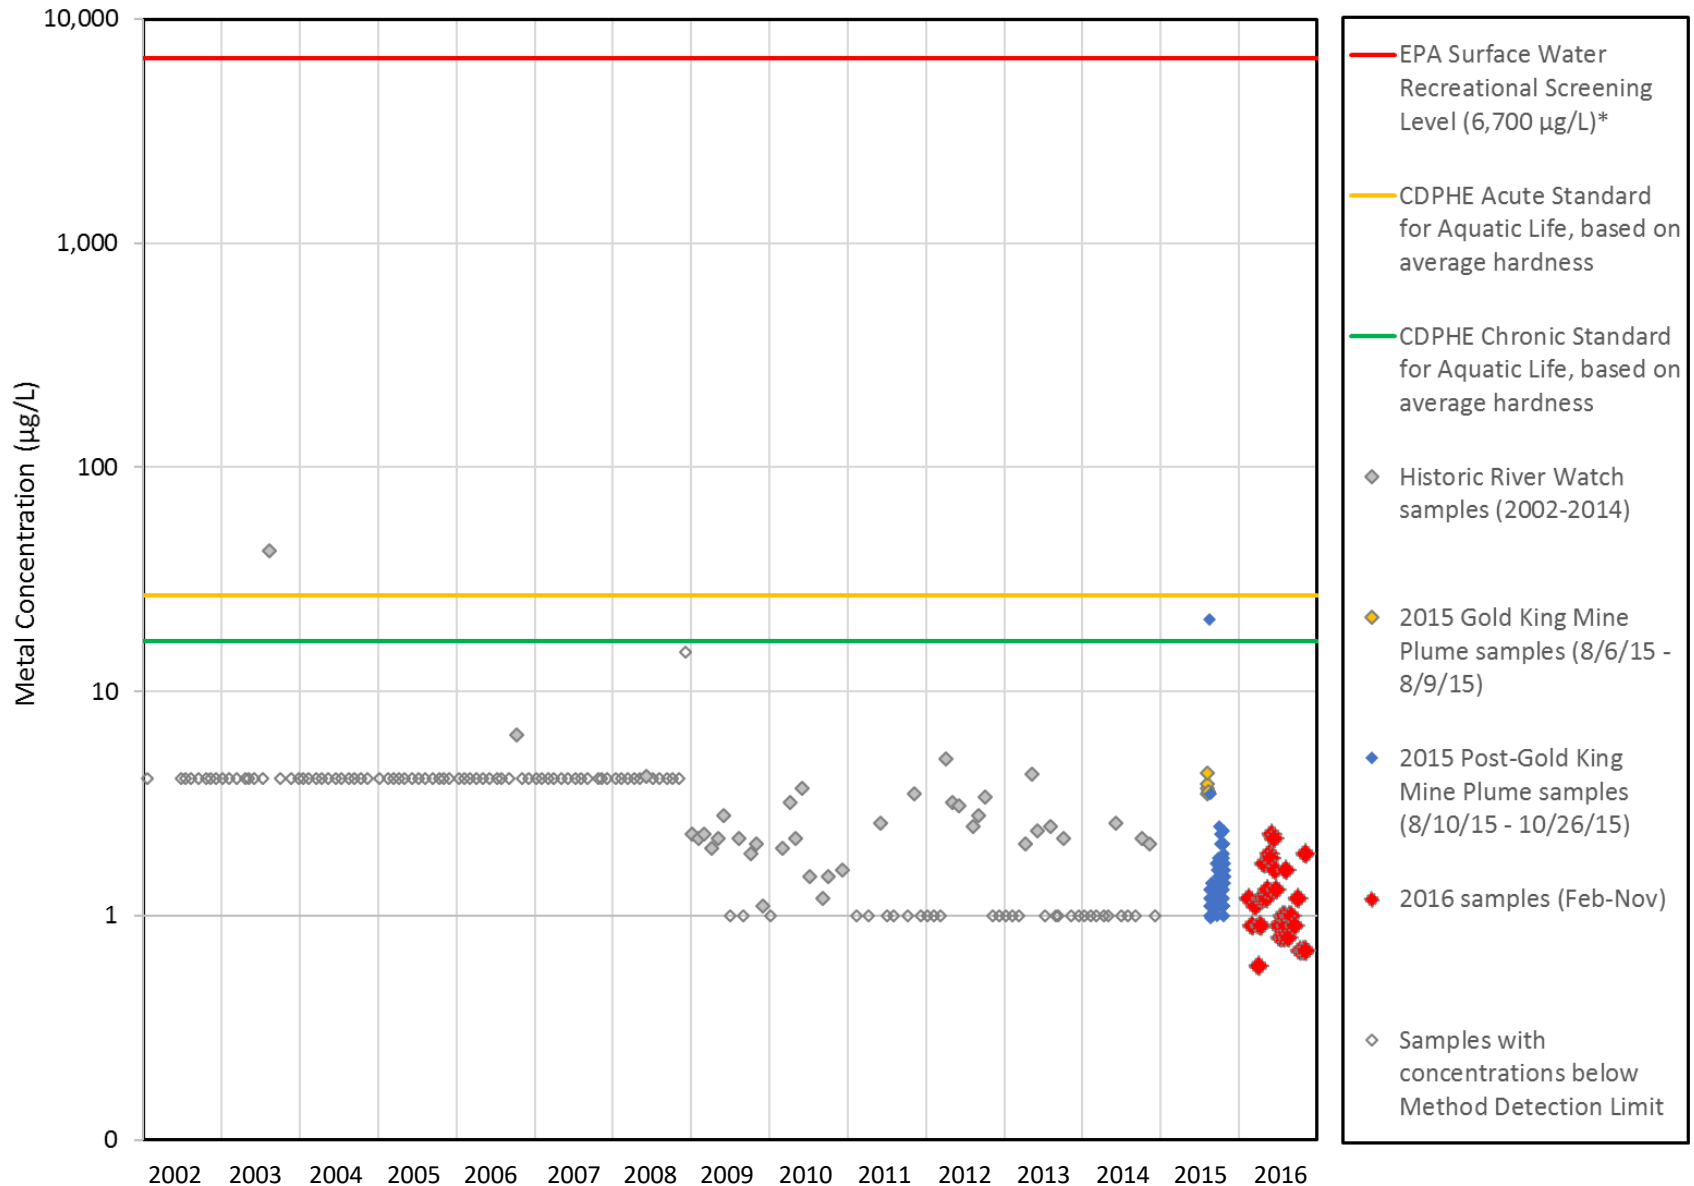
Dissolved Copper, Animas River at Durango, CO: 2002-2016

* The recreational screening level represents the level at which no adverse health effects are expected to occur in humans consuming 2L of water per day, from the Animas, orally, for 64 days each year for a total of 30 years.
 * Colorado Department of Public Health and the Environment (CDPHE) standards based on Colorado surface water quality classifications and Reg. 31 and 34. Standards vary with water hardness and are plotted here using an average water hardness of the Animas River at this location, 208 mg/L.

Note: 2002 - 2014 data is River Watch data from the Animas River at the fish hatchery in Durango, CO. 2015 and 2016 data is Mountain Studies Institute data from the Animas River at Rotary Park in Durango, CO

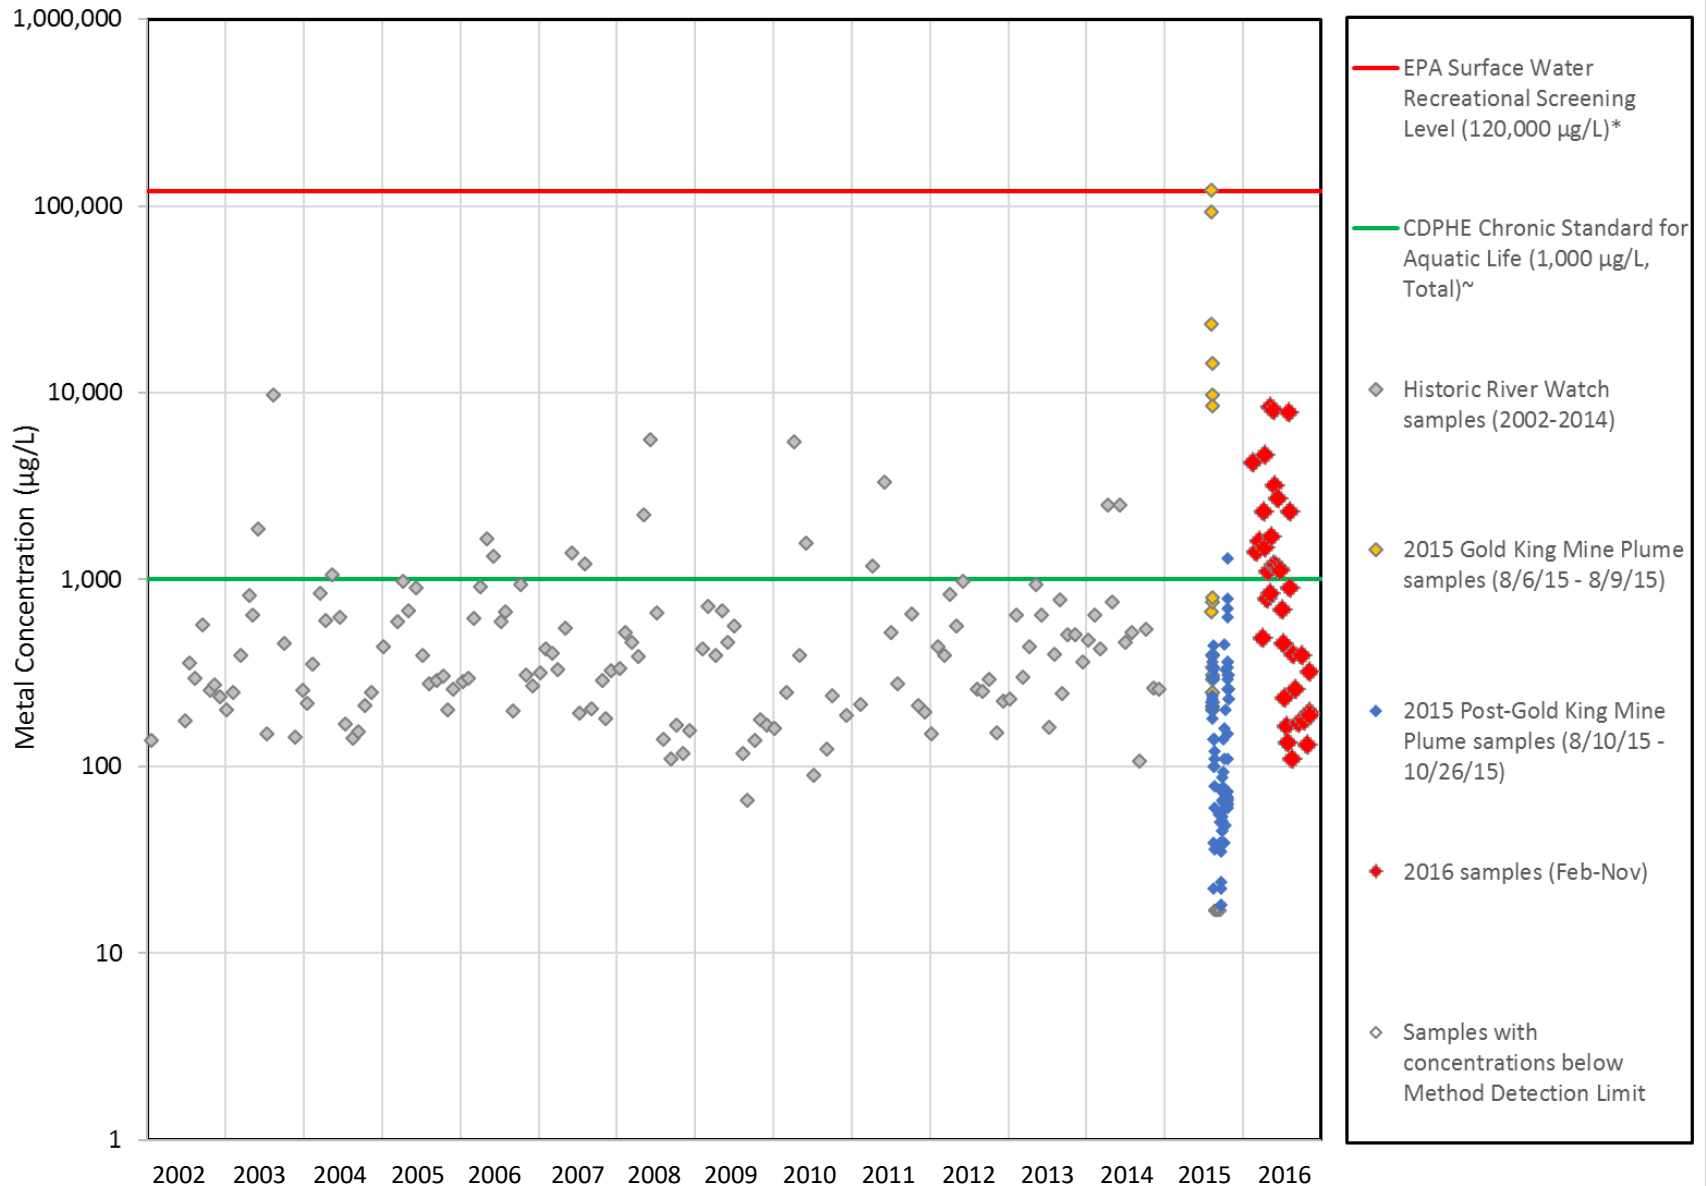
Total Iron, Animas River at Durango, CO: 2002-2016

* The recreational screening level represents the level at which no adverse health effects are expected to occur in humans consuming 2L of filtered water per day, from the Animas, orally, for 64 days each year for a total of 30 years.

~Colorado Department of Public Health and the Environment (CDPHE) standards based on Colorado surface water quality classifications and Reg. 31 and 34.

Note: 2002 - 2014 data is River Watch data from the Animas River at the fish hatchery in Durango, CO. 2015 and 2016 data is Mountain Studies Institute data from the Animas River at Rotary Park in Durango, CO

In 2016, concentrations of iron and aluminum reached levels of concern for long term exposure to aquatic life. CDPHE provides chronic water quality standards that are set to be protective of aquatic life from persistent, long-term exposure to metals. The chronic aquatic life water quality standard for iron is evaluated based on the median observed value. The median value for total iron over the 2016 monitoring period was 1,115 ug/L, which is higher than the CDPHE chronic aquatic life standard of 1,000 ug/L (CDPHE 2017). CDPHE evaluates chronic aluminum impairment by two methods (CDPHE 2015). The first method compares the 85th percentile of total aluminum concentration values to a chronic standard based on an average hardness value. For the 2016 Rotary Park data, the 85th percentile was 1,636 ug/L, which surpasses the average hardness based standard of 1,029 ug/L. The second method assigns a chronic standard for each sample based on the hardness value observed at the time the sample was collected. Impairment is designated if 50% of the samples exceed their paired chronic standard. For the 2016 Rotary Park data, 15 of 37 samples (41%) surpassed their paired chronic standard for aluminum, which is less than the 50% threshold that would designate impairment. CDPHE considers the second method (paired hardness-concentrations) more representative than the first method (based on average hardness) so although total aluminum concentrations were relatively high, they are not high enough to technically surpass the CDPHE chronic aquatic life standard for aluminum.

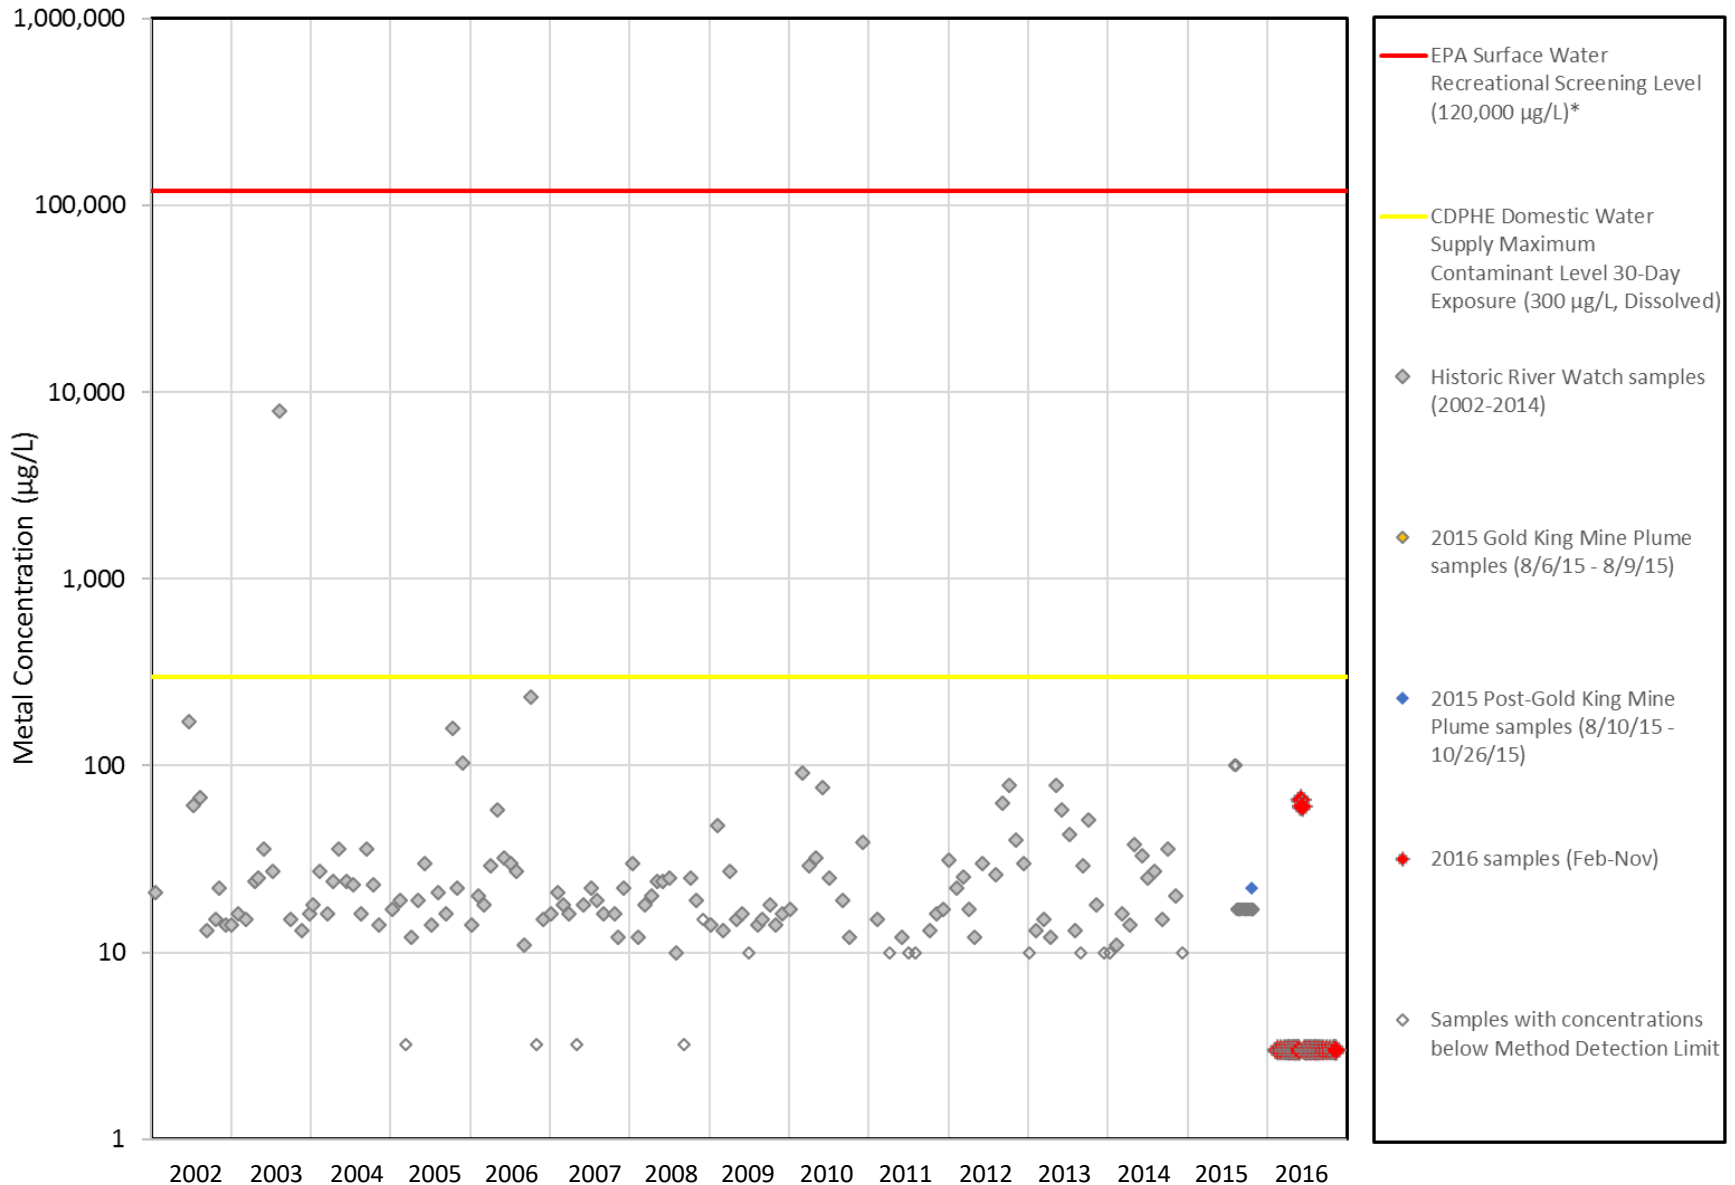
Dissolved Iron, Animas River at Durango, CO: 2002-2016

* The recreational screening level represents the level at which no adverse health effects are expected to occur in humans consuming 2L of filtered water per day, from the Animas, orally, for 64 days each year for a total of 30 years.

Note: 2002 - 2014 data is River Watch data from the Animas River at the fish hatchery in Durango, CO. 2015 and 2016 data is Mountain Studies Institute data from the Animas River at Rotary Park in Durango, CO.

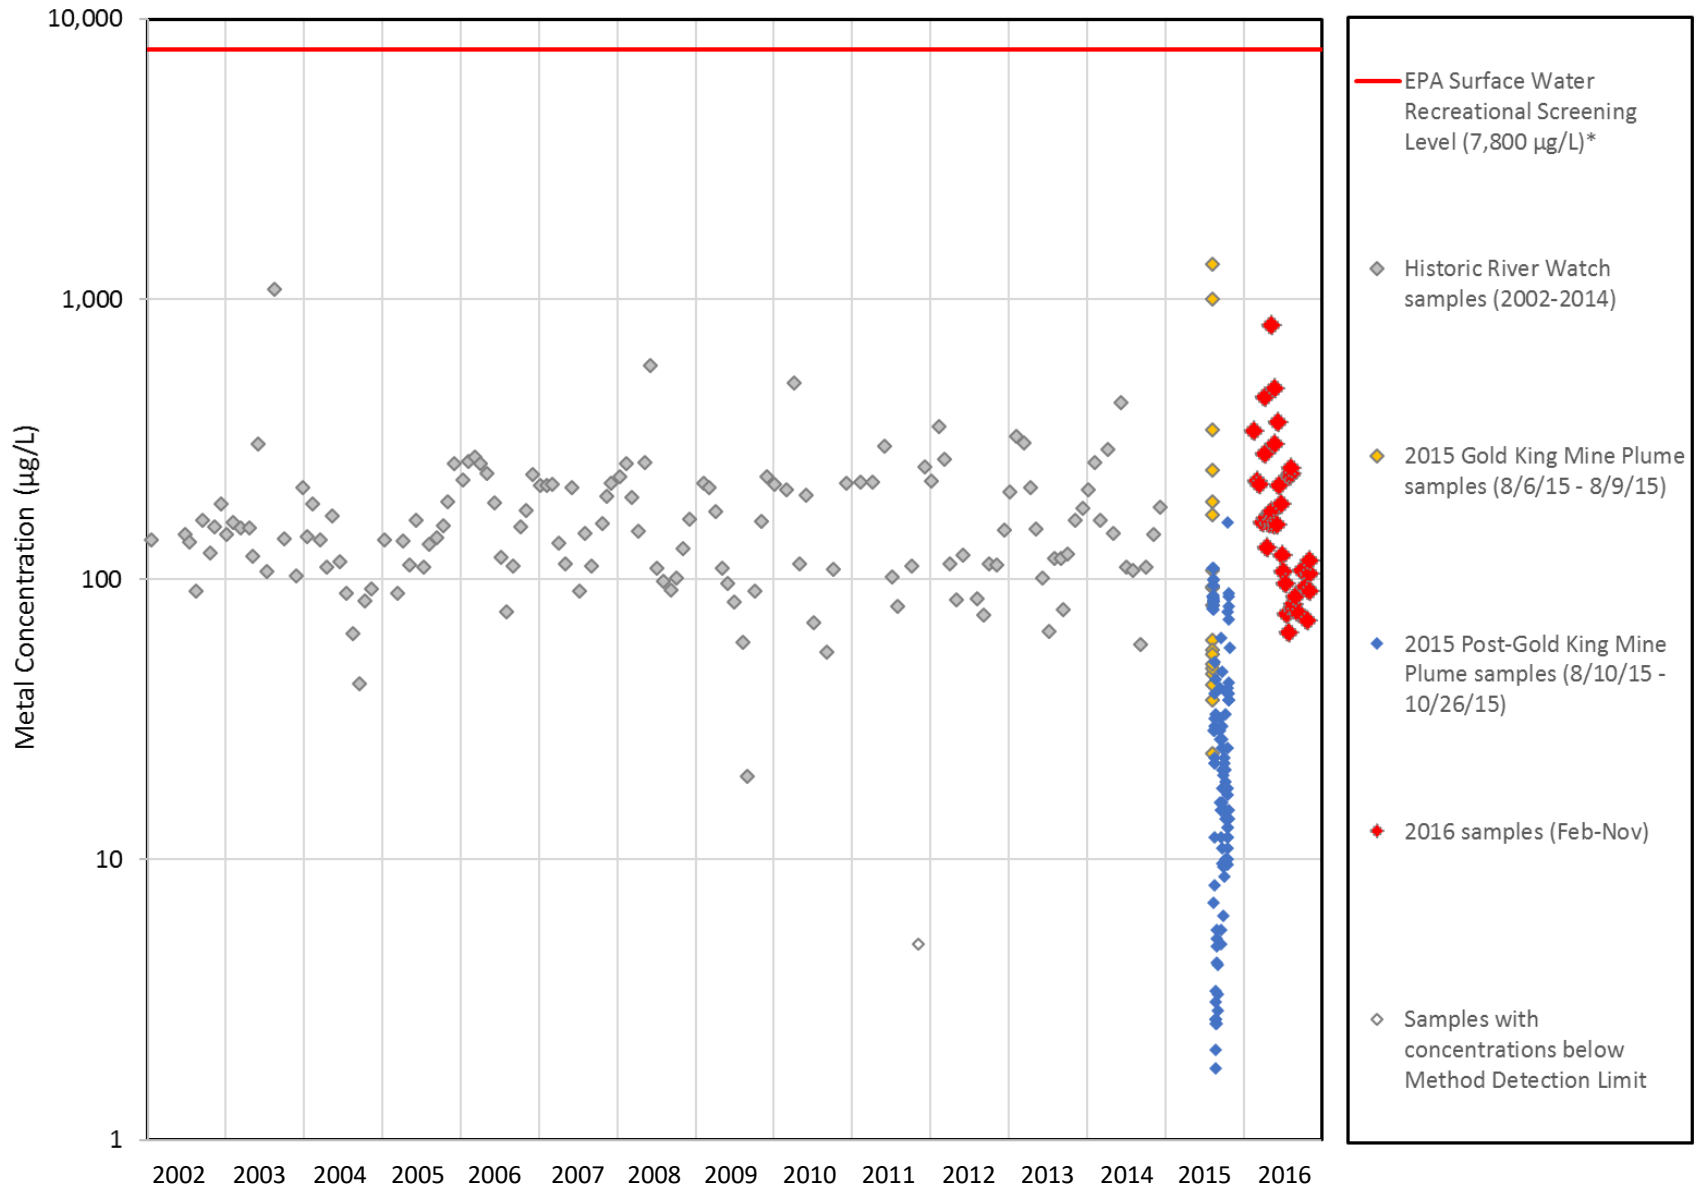
Total Manganese, Animas River at Durango, CO: 2002-2016

* The recreational screening level represents the level at which no adverse health effects are expected to occur in humans consuming 2L of filtered water per day, from the Animas, orally, for 64 days each year for a total of 30 years.

Note: 2002 - 2014 data is River Watch data from the Animas River at the fish hatchery in Durango, CO. 2015 and 2016 data is Mountain Studies Institute data from the Animas River at Rotary Park in Durango, CO

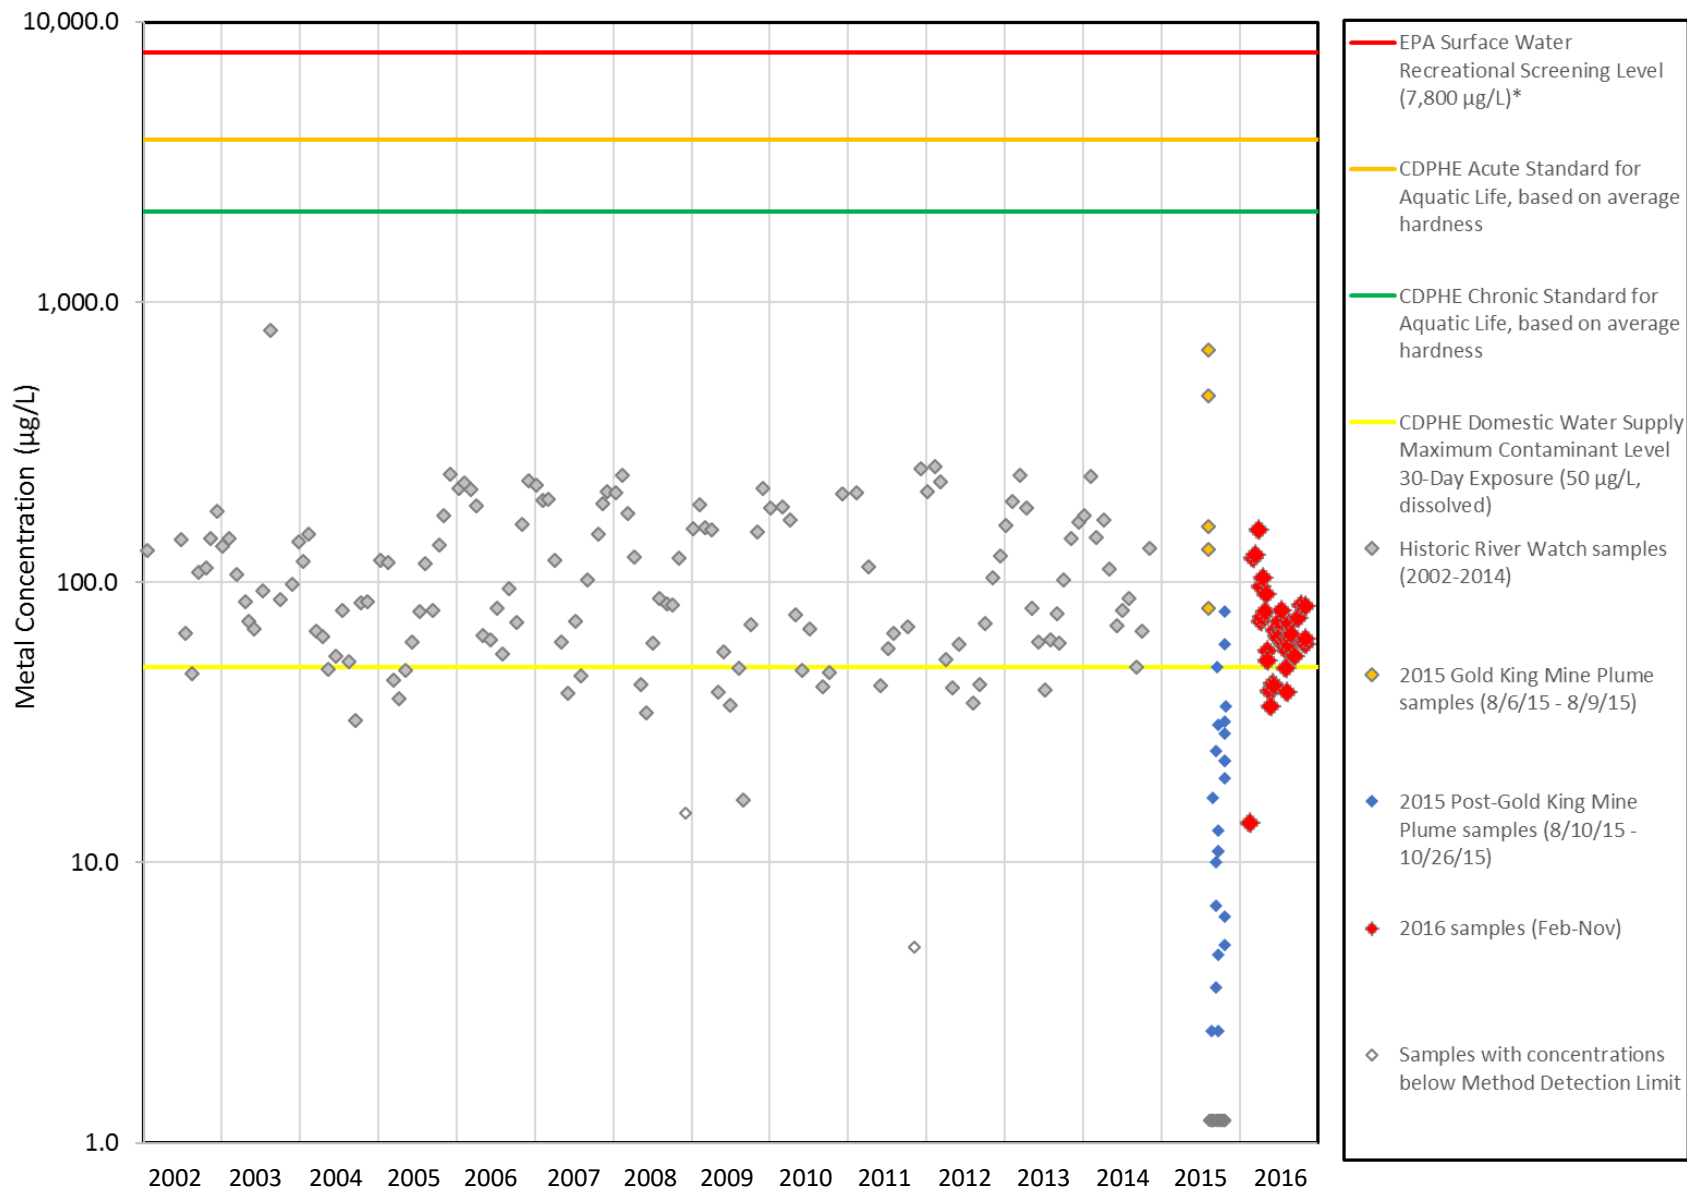
Dissolved Manganese, Animas River at Durango, CO: 2002-2016

* The recreational screening level represents the level at which no adverse health effects are expected to occur in humans consuming 2L of filtered water per day, from the Animas, orally, for 64 days each year for a total of 30 years.

Note: 2002 - 2014 data is River Watch data from the Animas River at the fish hatchery in Durango, CO. 2015 and 2016 data is Mountain Studies Institute data from the Animas River at Rotary Park in Durango, CO.
