Summary of 2016 Animas River Water Quality Monitoring at Rotary Park in Durango, CO

Monitoring Program Overview

Appendix A:

Appendix B:

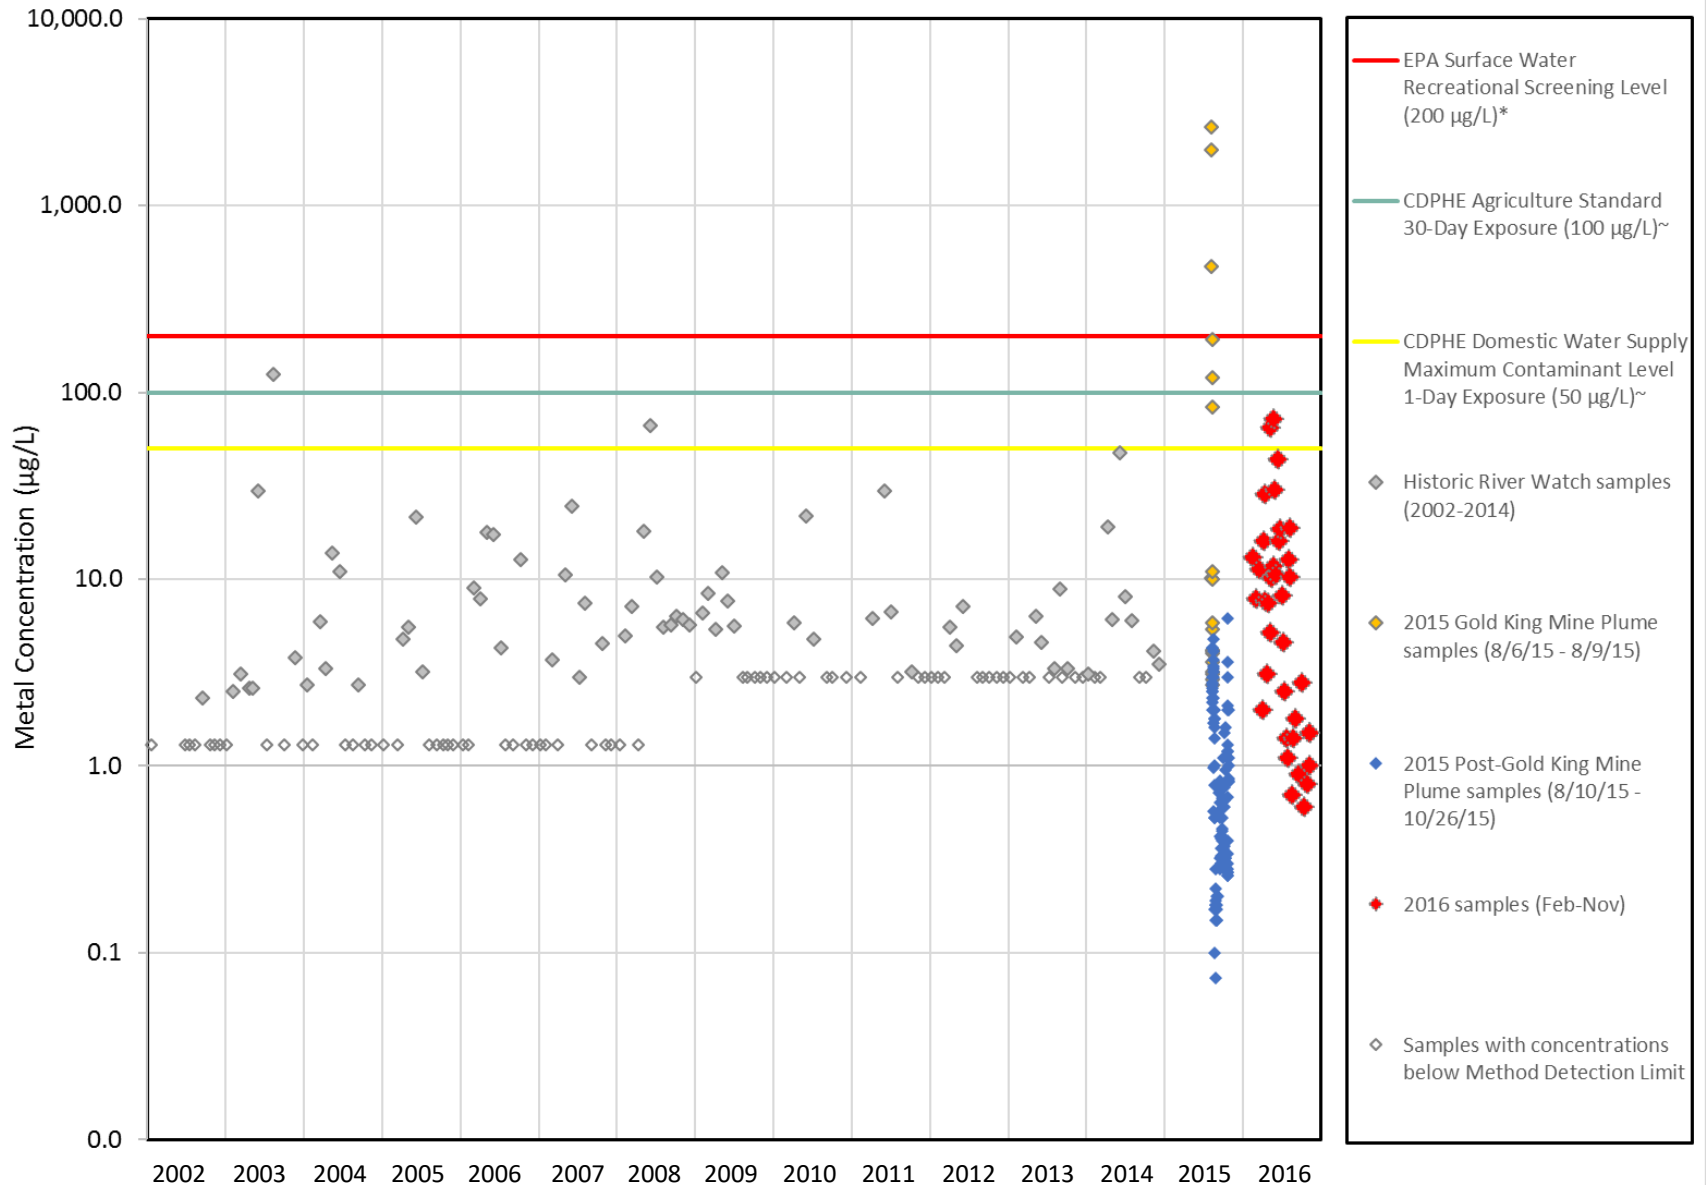
Total Lead, Animas River at Durango, CO: 2002-2016

* The recreational screening level represents the level at which no adverse health effects are expected to occur in humans consuming 2L of water per day, from the Animas, orally, for 64 days each year for a total of 30 years.

~Colorado Department of Public Health and the Environment (CDPHE) standards based on Colorado surface water quality classifications and Reg. 31 and 34.

Note: 2002 - 2014 data is River Watch data from the Animas River at the fish hatchery in Durango, CO. 2015 and 2016 data is Mountain Studies Institute data from the Animas River at Rotary Park in Durango, CO.

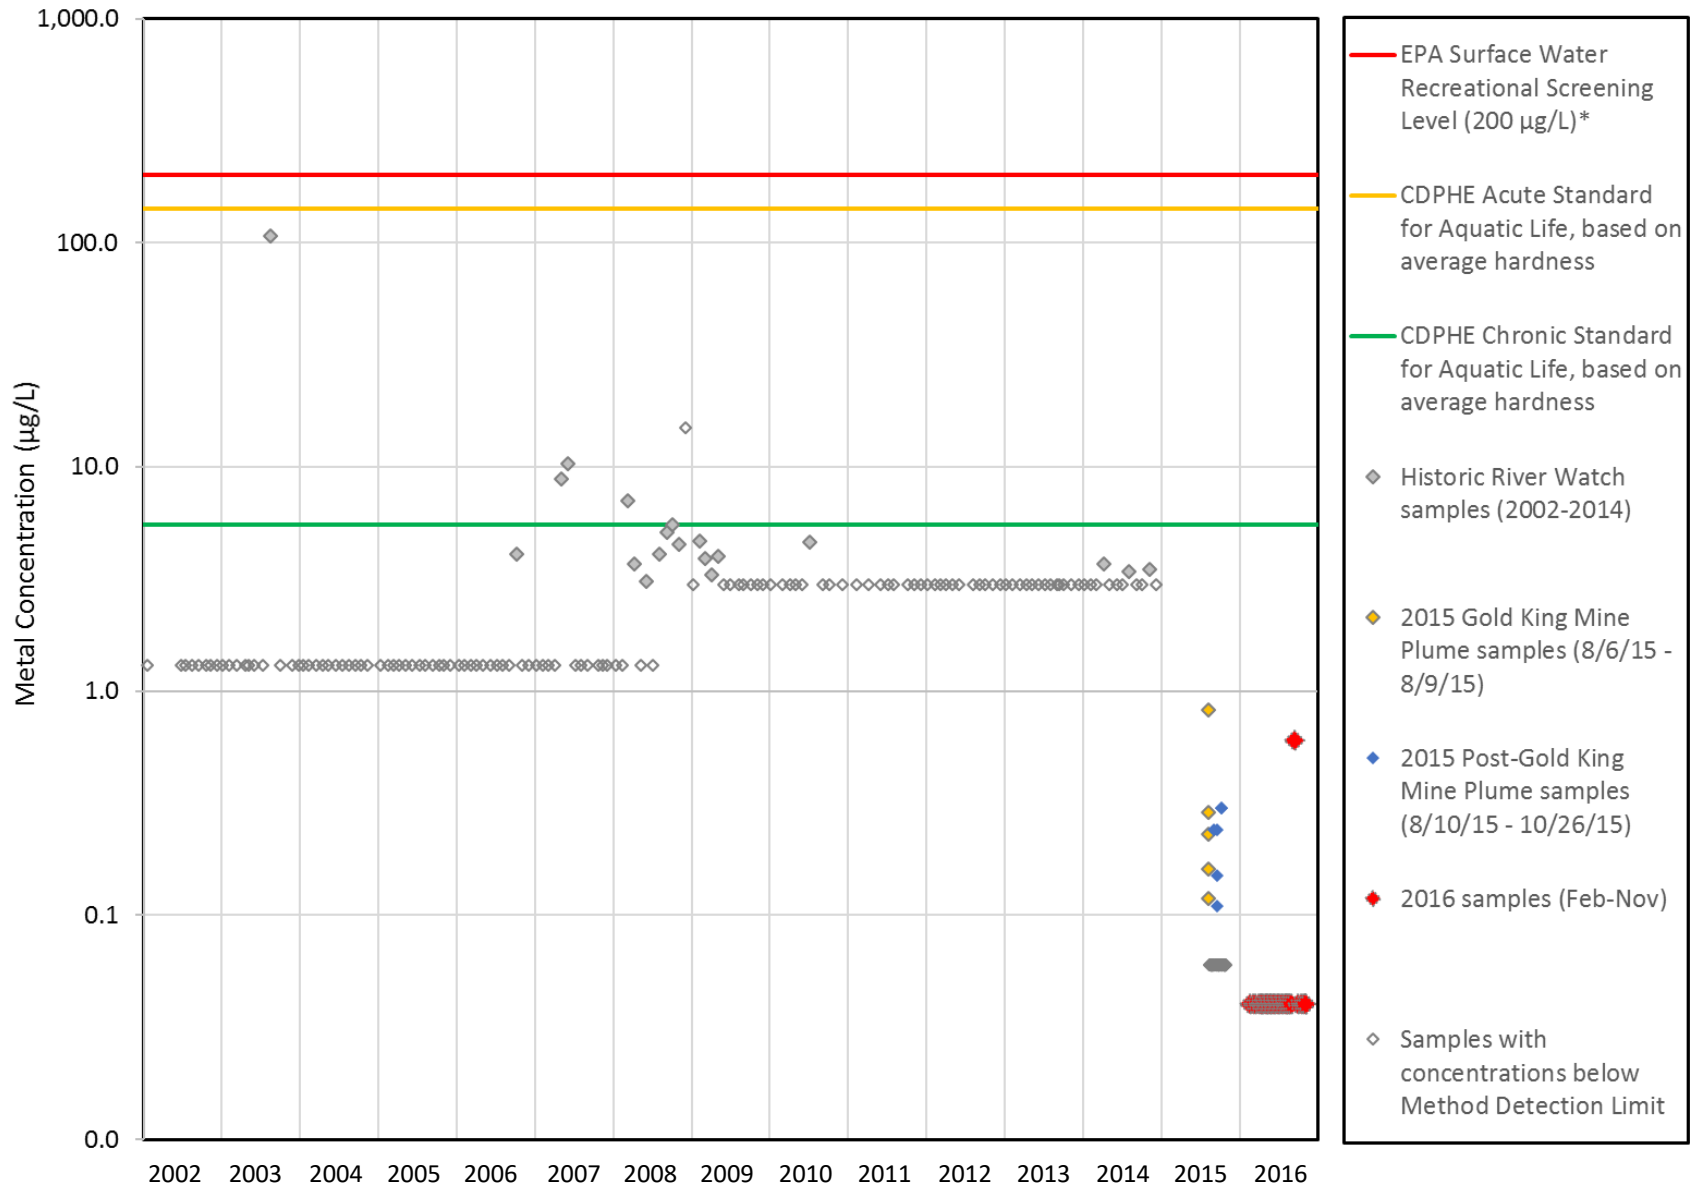
Dissolved Lead, Animas River at Durango, CO: 2002-2016

* The recreational screening level represents the level at which no adverse health effects are expected to occur in humans consuming 2L of filtered water per day, from the Animas, orally, for 64 days each year for a total of 30 years.

Note: 2002 - 2014 data is River Watch data from the Animas River at the fish hatchery in Durango, CO. 2015 and 2016 data is Mountain Studies Institute data from the Animas River at Rotary Park in Durango, CO.

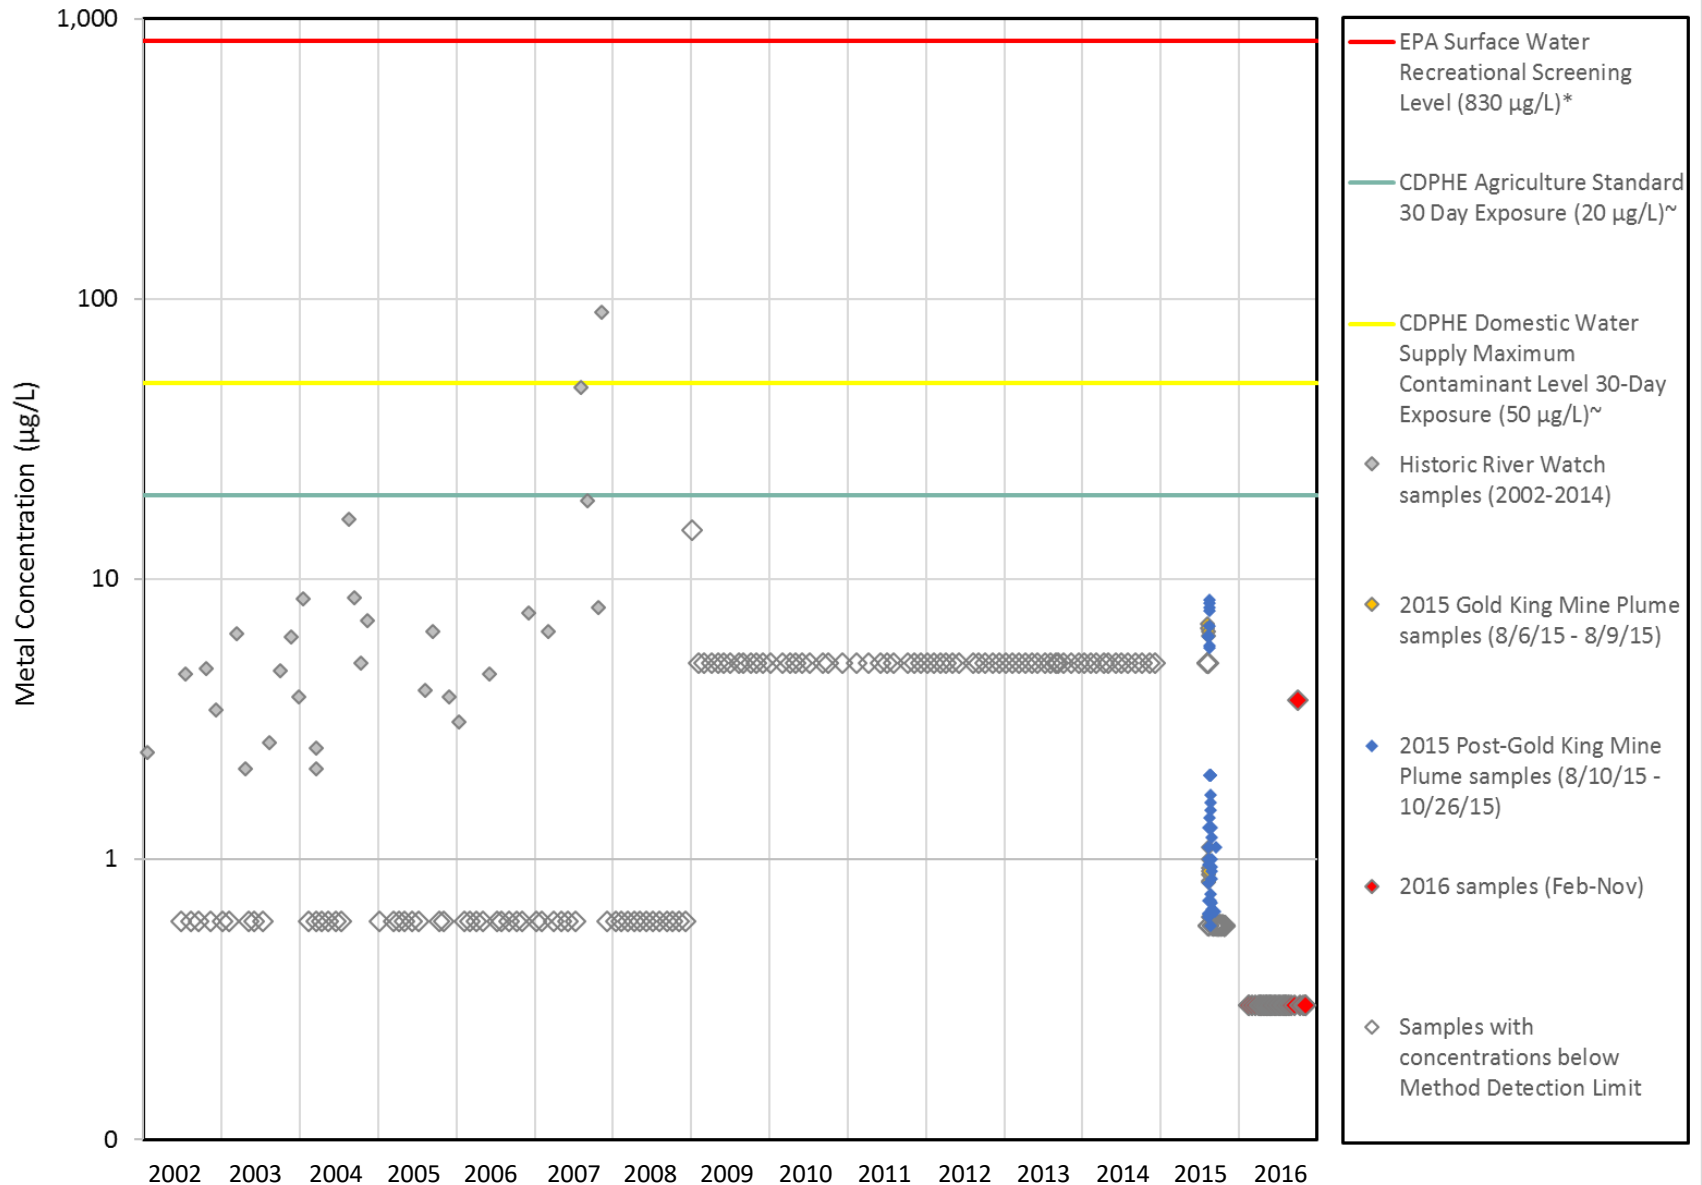
Total Selenium, Animas River at Durango, CO: 2002-2016

* The recreational screening level represents the level at which no adverse health effects are expected to occur in humans consuming 2L of filtered water per day, from the Animas, orally, for 64 days each year for a total of 30 years.

~Colorado Department of Public Health and the Environment (CDPHE) standards based on Colorado surface water quality classifications and Reg. 31 and 34.

Note: 2002 - 2014 data is River Watch data from the Animas River at the fish hatchery in Durango, CO. 2015 and 2016 data is Mountain Studies Institute data from the Animas River at Rotary Park in Durango, CO.

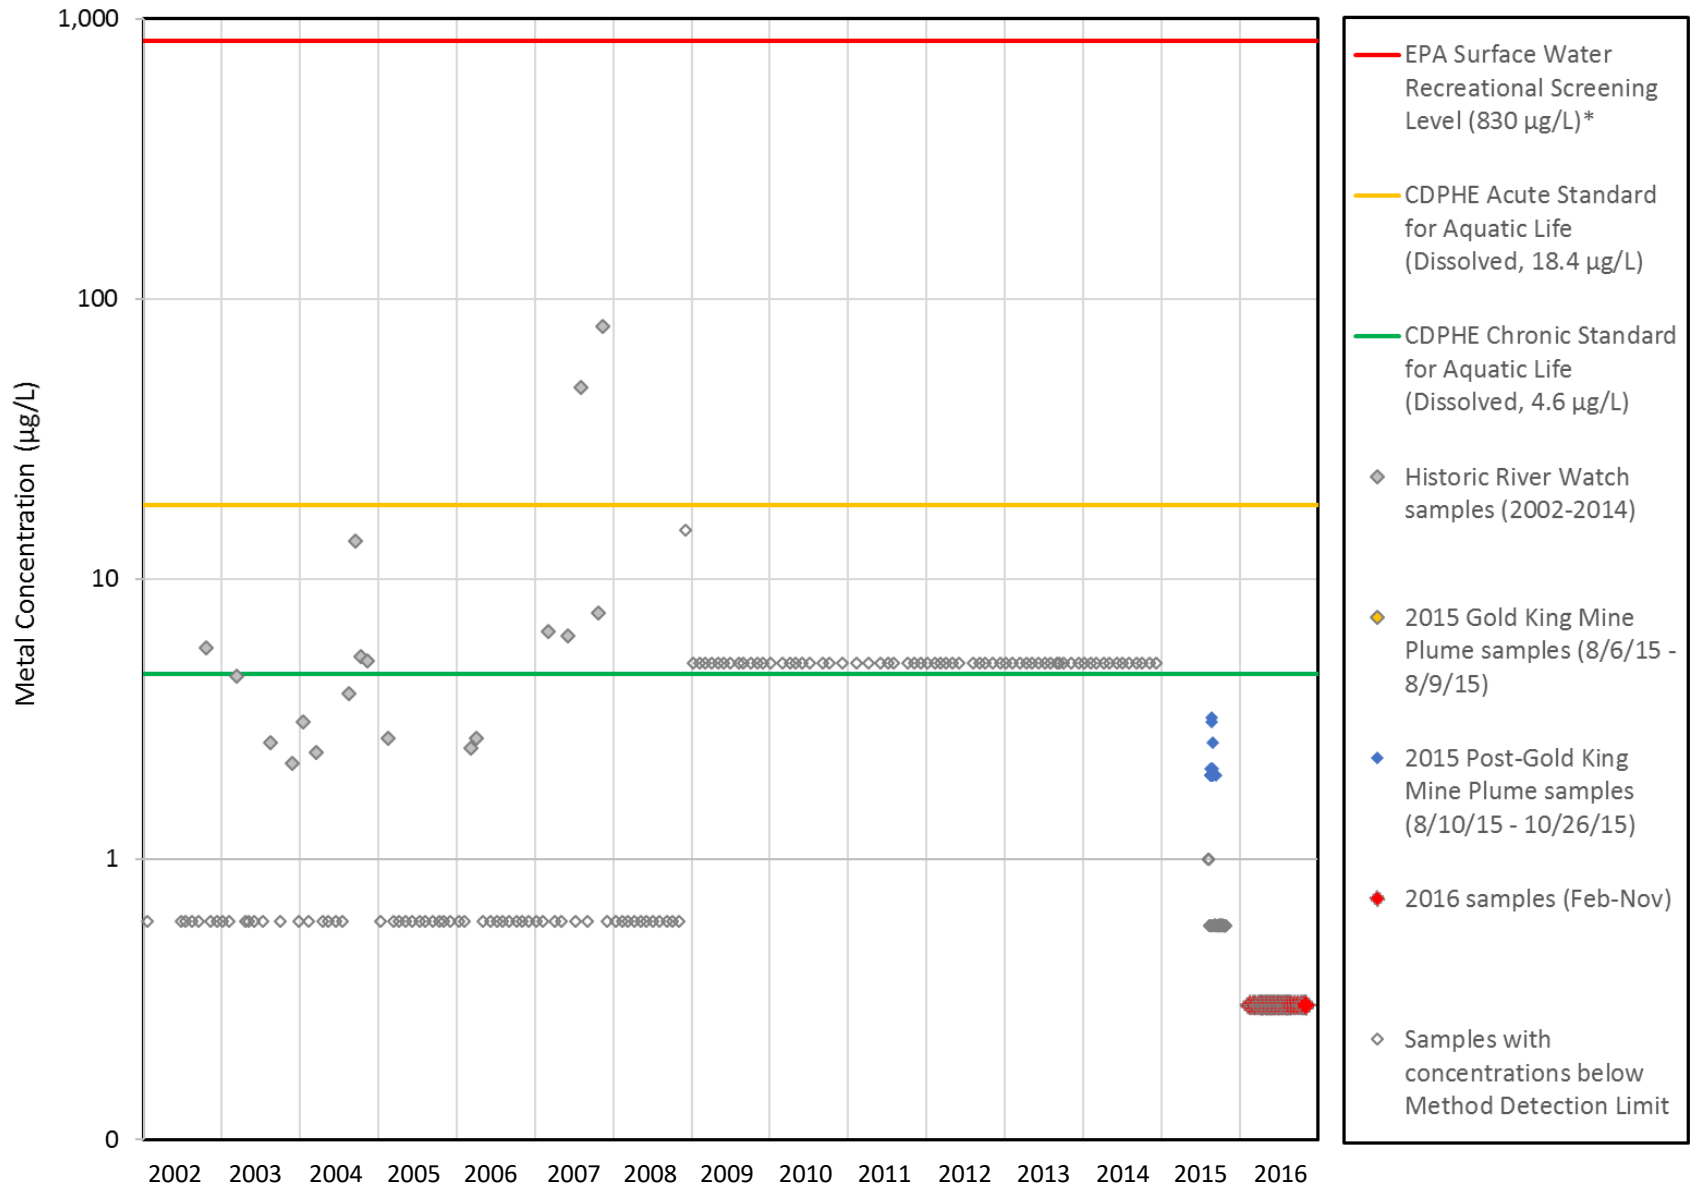
Dissolved Selenium, Animas River at Durango, CO: 2002-2016

* The recreational screening level represents the level at which no adverse health effects are expected to occur in humans consuming 2L of filtered water per day, from the Animas, orally, for 64 days each year for a total of 30 years.

Note: 2002 - 2014 data is River Watch data from the Animas River at the fish hatchery in Durango, CO. 2015 and 2016 data is Mountain Studies Institute data from the Animas River at Rotary Park in Durango, CO.

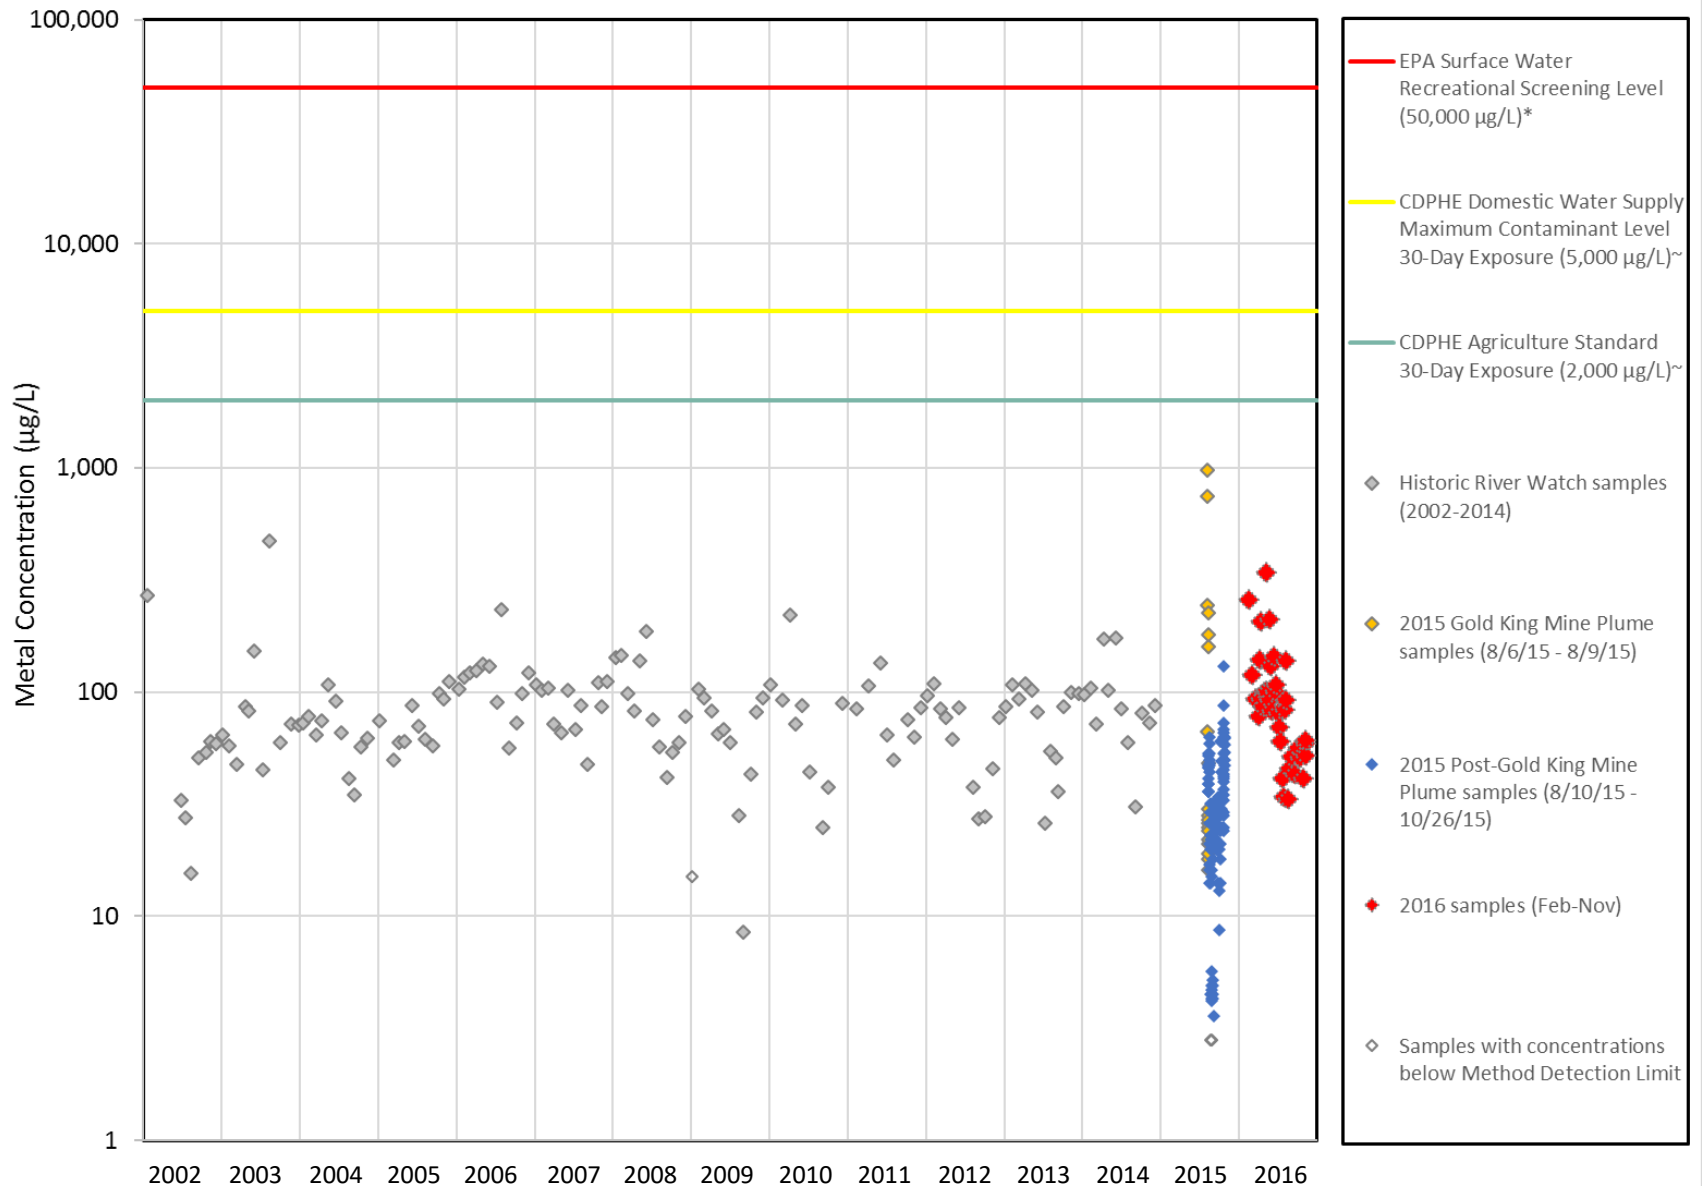
Total Zinc, Animas River at Durango, CO: 2002-2016

* The recreational screening level represents the level at which no adverse health effects are expected to occur in humans consuming 2L of water per day, from the Animas, orally, for 64 days each year for a total of 30 years.

~Colorado Department of Public Health and the Environment (CDPHE) standards based on Colorado surface water quality classifications and Reg. 31 and 34.

Note: 2002 - 2014 data is River Watch data from the Animas River at the fish hatchery in Durango, CO. 2015 data is Mountain Studies Institute data from the Animas River at Rotary Park in Durango, CO

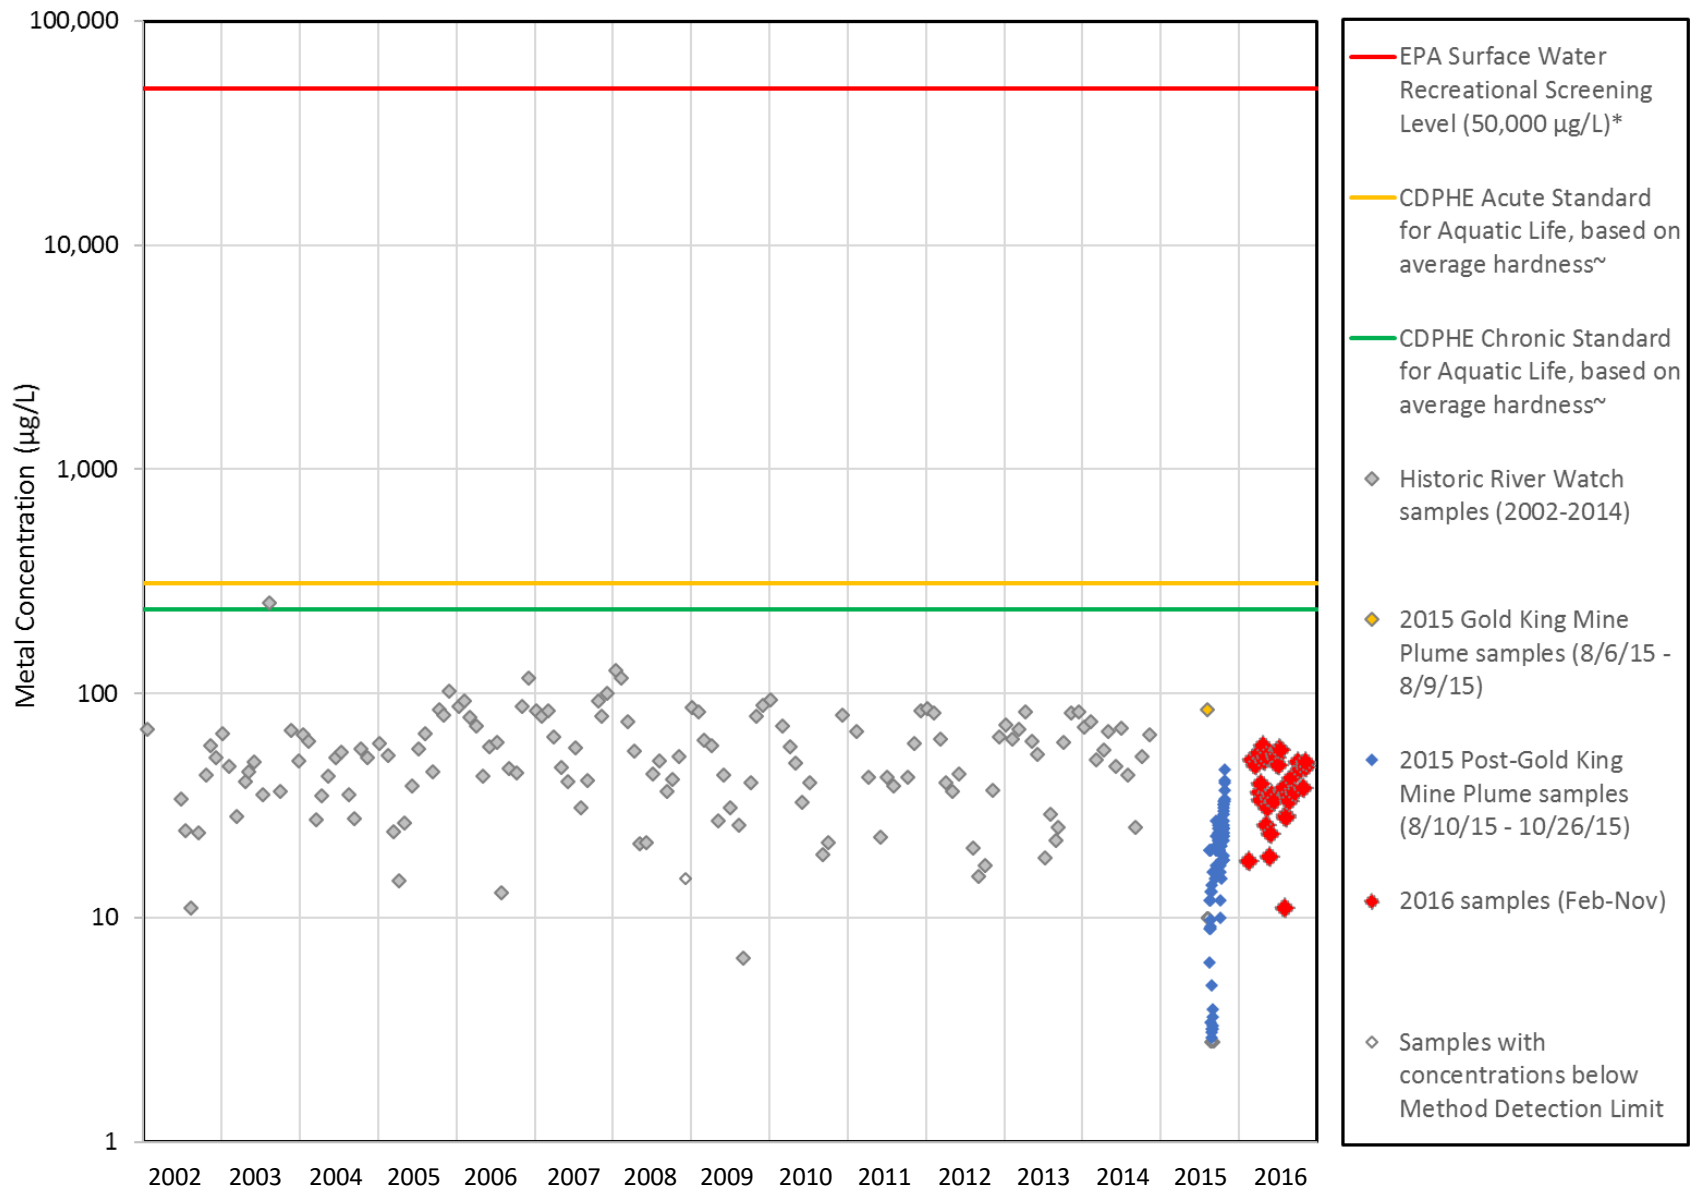
Dissolved Zinc, Animas River at Durango, CO: 2002-2016

* The recreational screening level represents the level at which no adverse health effects are expected to occur in humans consuming 2L of water per day, from the Animas, orally, for 64 days each year for a total of 30 years.

~Colorado Department of Public Health and the Environment (CDPHE) standards based on Colorado surface water quality classifications and Reg. 31 and 34. Standards vary with water hardness and are plotted here using an average water hardness of the Animas River at this location, 208 mg/L.

Note: 2002 - 2014 data is River Watch data from the Animas River at the fish hatchery in Durango, CO. 2015 and 2016 data is Mountain Studies Institute data from the Animas River at Rotary Park in Durango, CO

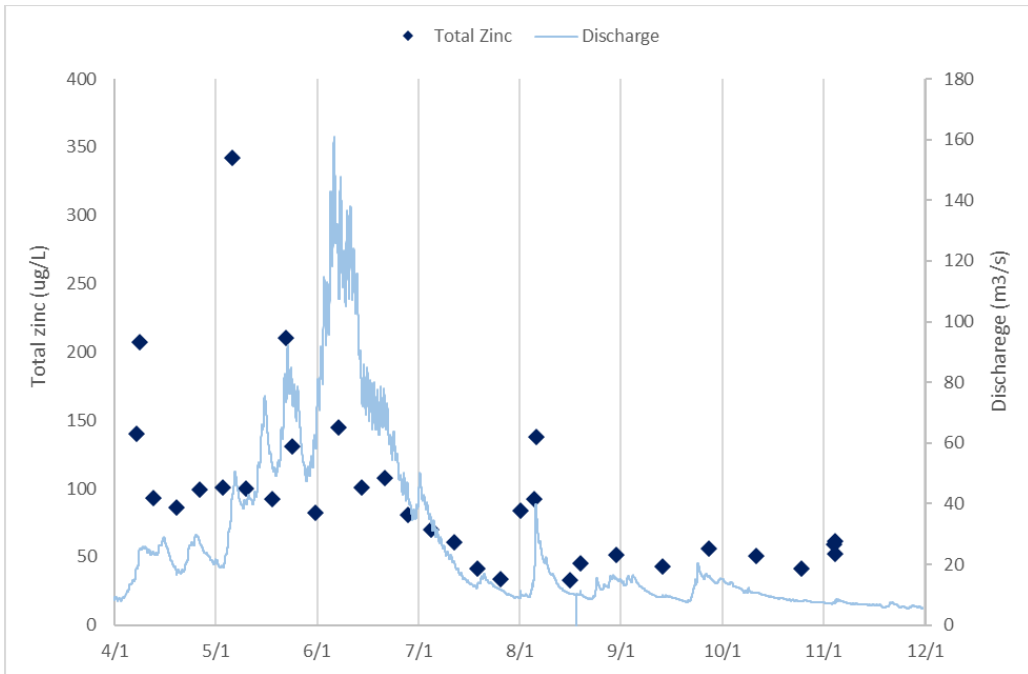
Figure 1: Discharge and total zinc.

Metals and Other Water Quality Parameters: Correlation statistics and an example graph of the four USGS water quality parameters: discharge, turbidity, pH, and conductivity

In 2016, USGS began to provide continuous measurement of pH, turbidity, and conductivity at their Animas River gauge in Durango, CO (data available at <https://waterdata.usgs.gov/nwis/uv?09361500>). MSI examined the relationship between metal concentrations and these additional water quality parameters (Figures 1-3). Spearman correlation coefficients indicate that several metals correlated at a statistically significant level with discharge, turbidity, pH, and conductivity (Table 3).

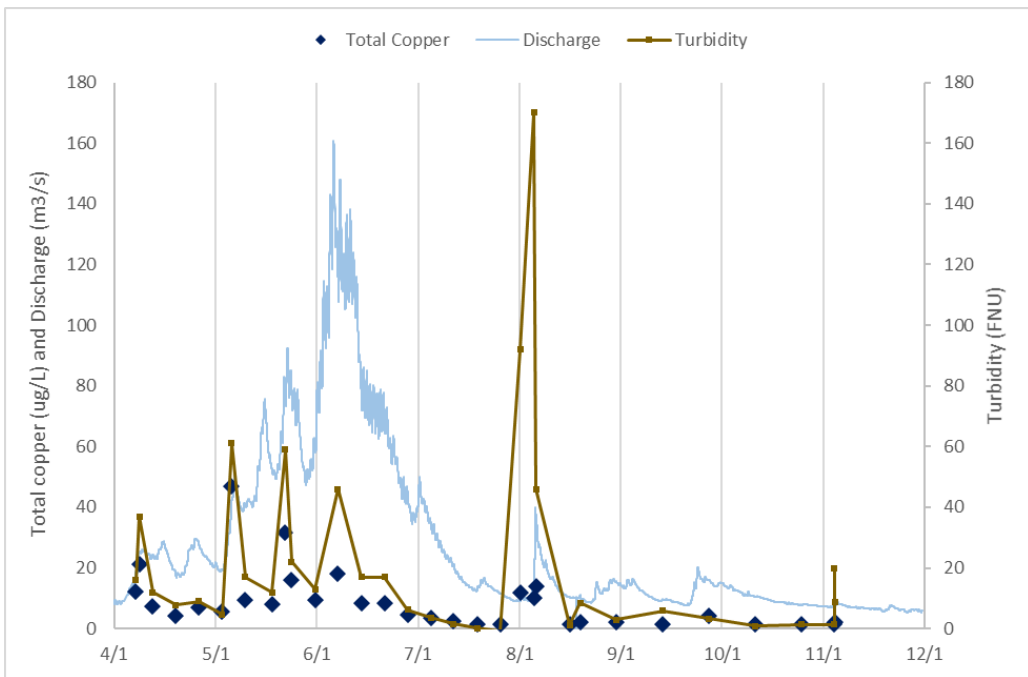
Figure 2: Turbidity and total copper.

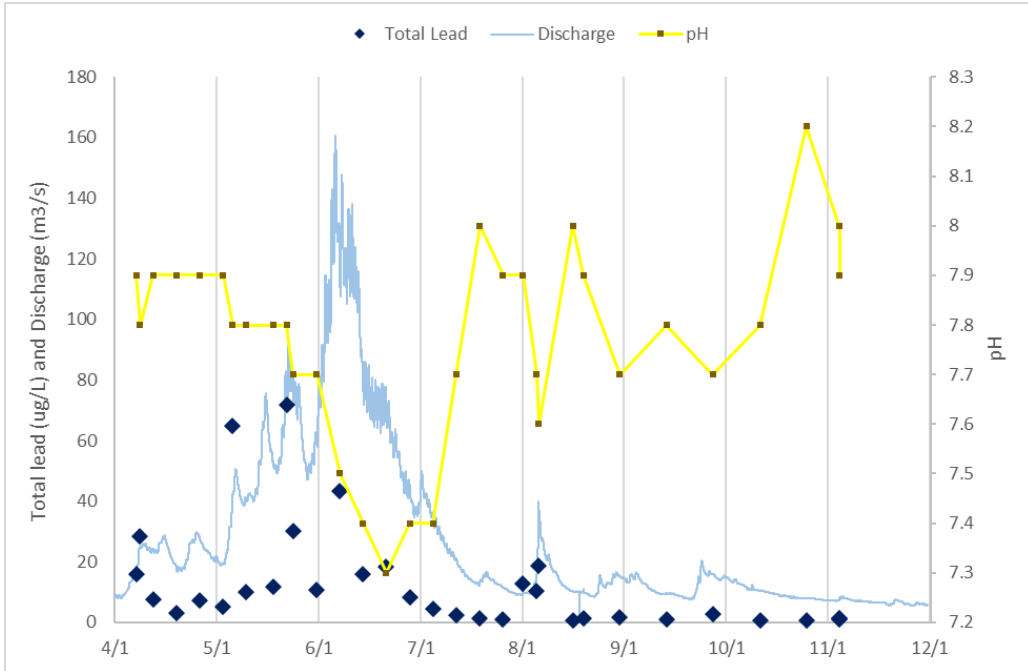
Figure 3: pH and total lead.

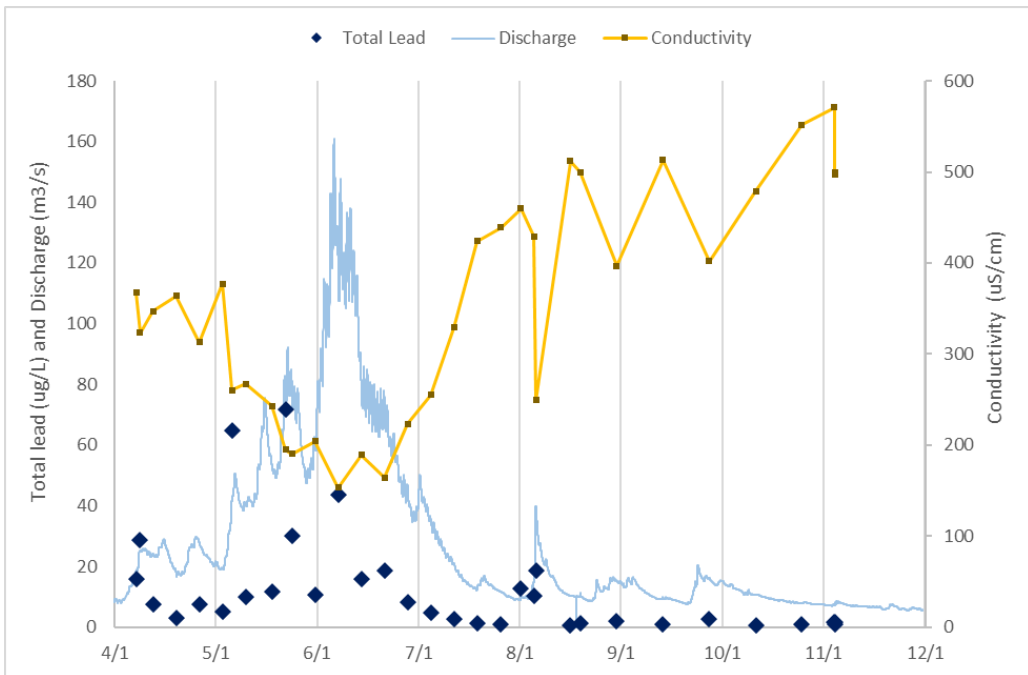
Figure 4: Conductivity and total lead.
