Mountain Studies Institute (MSI) has been monitoring water quality of the Animas River at Rotary Park in Durango before, during, and after the 2015 Gold King Mine release. We plan to continue monitoring during spring runoff in 2016. We collected our first water quality sample of the season on February 15 2016 and now have water quality data from February, March, April, and May.

Animas River at Rotary Park in Durango, CO

SAN JUAN MOUNTAINS, CO

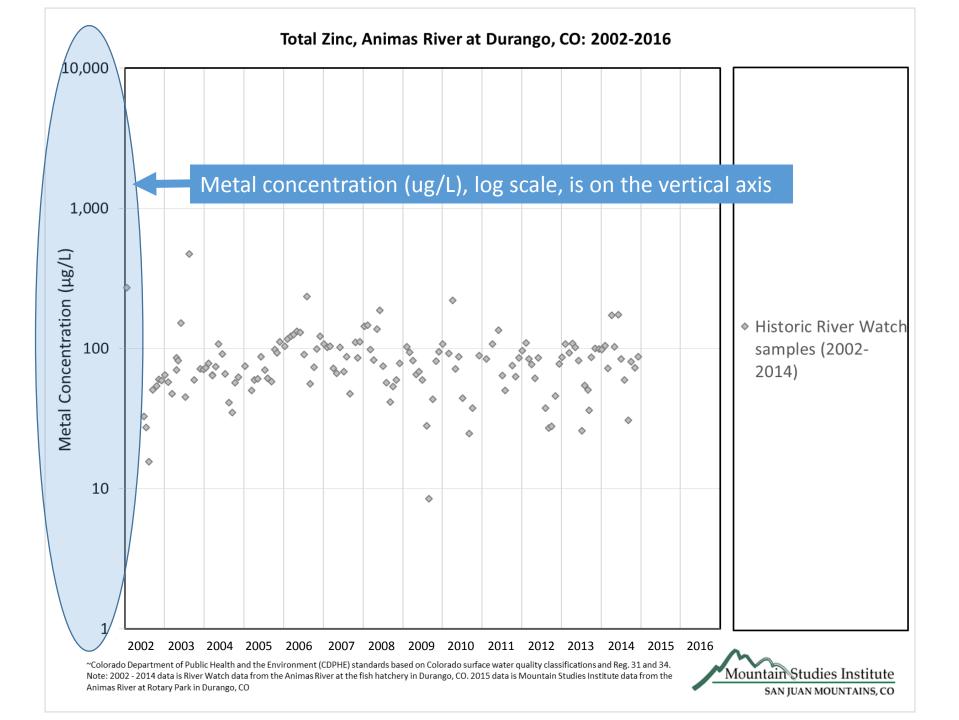
Total Zinc, Animas River at Durango, CO: 2002-2016 10,000 Grey diamonds = Historic River Watch samples from the Animas River – 2002 to 2014 1,000 Metal Concentration (μg/L) **\psi** Historic River Watch 100 samples (2002-2014) 10 0 2006 2007 2008 2009 2010 2011 2012 2013 2014 2016 ~Colorado Department of Public Health and the Environment (CDPHE) standards based on Colorado surface water quality classifications and Reg. 31 and 34.

~Colorado Department of Public Health and the Environment (CDPHE) standards based on Colorado surface water quality classifications and Reg. 31 and 34. Note: 2002 - 2014 data is River Watch data from the Animas River at the fish hatchery in Durango, CO. 2015 data is Mountain Studies Institute data from the Animas River at Rotary Park in Durango, CO

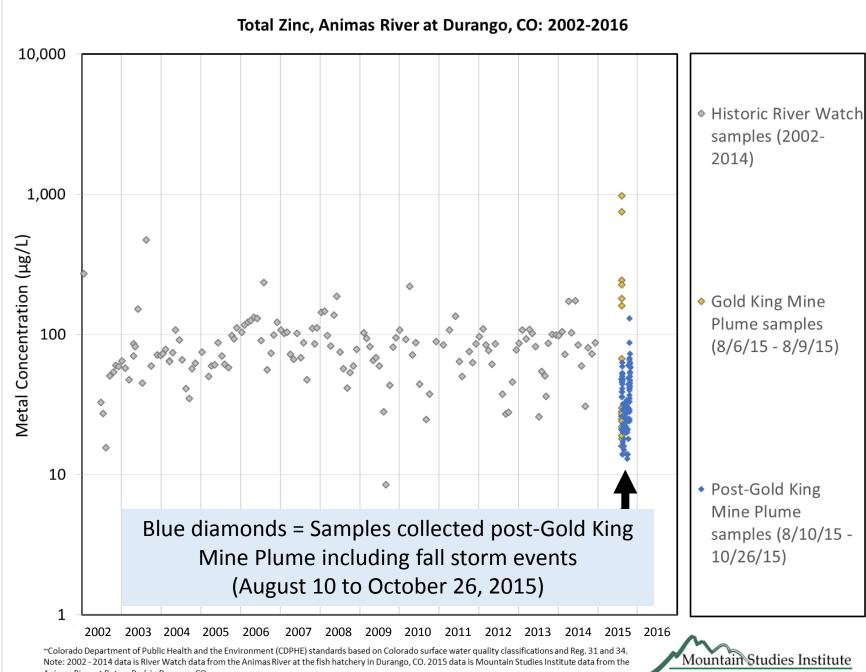
Total Zinc, Animas River at Durango, CO: 2002-2016 10,000 Orange diamonds = Samples collected during the Gold King Mine Plume (August 6 to August 9, 2015) Historic River Watch samples (2002-1,000 2014) Metal Concentration (μg/L) 100 Gold King Mine 10 Plume samples (8/6/15 - 8/9/15)1 2006 2007 2008 2009 2011 2012 2013 2014 2016 2010 ~Colorado Department of Public Health and the Environment (CDPHE) standards based on Colorado surface water quality classifications and Reg. 31 and 34. Mountain Studies Institute Note: 2002 - 2014 data is River Watch data from the Animas River at the fish hatchery in Durango, CO. 2015 data is Mountain Studies Institute data from the

Total Zinc, Animas River at Durango, CO: 2002-2016 10,000 ◆ Spring 2016 Red diamonds = Sample collected this spring samples 1,000 Historic River Watch Metal Concentration (μg/L) **\psi** samples (2002-2014) 100 Gold King Mine Plume samples (8/6/15 - 8/9/15)10 0 Post-Gold King Mine Plume samples (8/10/15 -10/26/15) 1 2006 2007 2008 2009 2011 2012 2013 2014 2016 2010 ~Colorado Department of Public Health and the Environment (CDPHE) standards based on Colorado surface water quality classifications and Reg. 31 and 34.

~Colorado Department of Public Health and the Environment (CDPHE) standards based on Colorado surface water quality classifications and Reg. 31 and 34. Note: 2002 - 2014 data is River Watch data from the Animas River at the fish hatchery in Durango, CO. 2015 data is Mountain Studies Institute data from the Animas River at Rotary Park in Durango, CO

Question = How does the spring 2016 concentrations compare to concentrations during the 2015 Gold King Mine plume?

Answer = Spring 2016 concentrations were <u>less</u> than concentrations observed at the peak of the Gold King Mine plume.

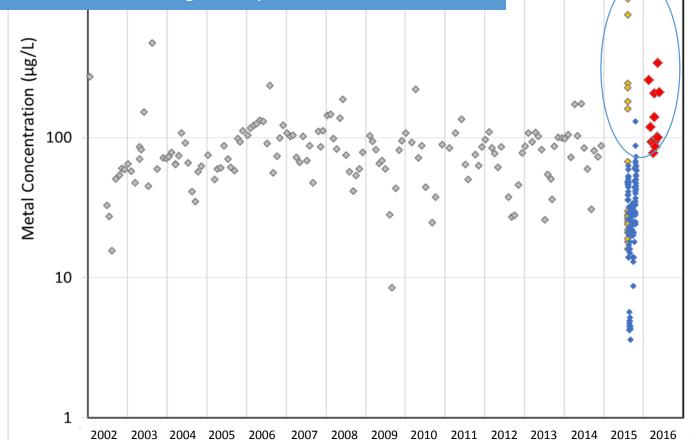
Total Zinc, Animas River at Durango, CO: 2002-2016

◆ Spring 2016 samples

Historic River Watch samples (2002-2014)

Gold King Mine Plume samples (8/6/15 - 8/9/15)

Post-Gold King Mine Plume samples (8/10/15 -10/26/15)

~Colorado Department of Public Health and the Environment (CDPHE) standards based on Colorado surface water quality classifications and Reg. 31 and 34. Note: 2002 - 2014 data is River Watch data from the Animas River at the fish hatchery in Durango, CO. 2015 data is Mountain Studies Institute data from the Animas River at Rotary Park in Durango, CO

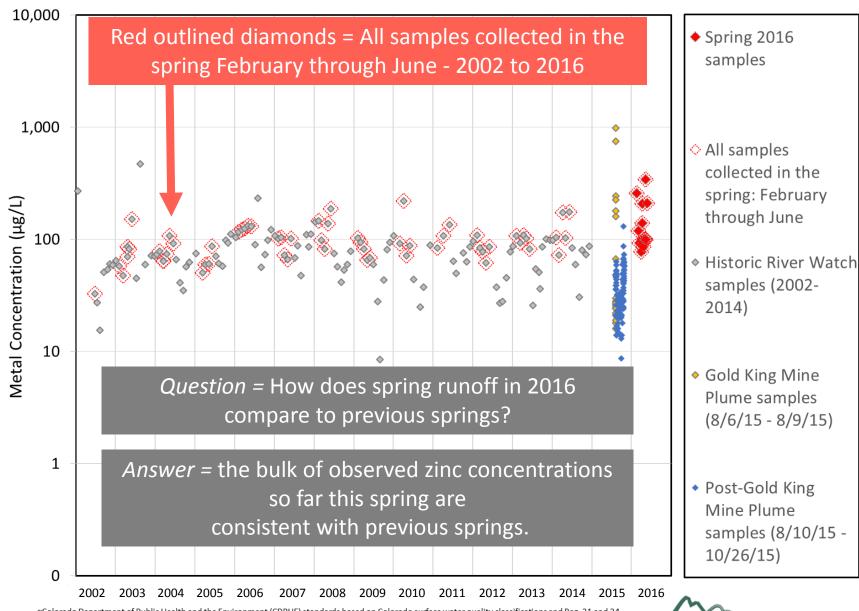
~Colorado Department of Public Health and the Environment (CDPHE) standards based on Colorado surface water quality classifications and Reg. 31 and 34.

Note: 2002 - 2014 data is River Watch data from the Animas River at the fish hatchery in Durango, CO. 2015 data is Mountain Studies Institute data from the Animas River at Rotary Park in Durango, CO

Total Zinc, Animas River at Durango, CO: 2002-2016 100,000 EPA Surface Water Recreational Screening Level (50,000 μg/L)* 10,000 EPA – Recreational Screening Level Spring 2016 samples Set to protect use of the Animas River for recreation 1,000 Protective of users who accidentally swallow river water (swimmers, rafters, tubers) or users who intentionally All samples collected in the Metal Concentration (μg/L) spring: February through ingest river water (backpackers, overnight river users) June 100 Historic River Watch samples (2002-2014) 10 0 Gold King Mine Plume samples (8/6/15 - 8/9/15) 1 Post-Gold King Mine Plume samples (8/10/15 -10/26/15) 0 2007 2008 2016 ~Colorado Department of Public Health and the Environment (CDPHE) standards based on Colorado surface water quality classifications and Reg. 31 and 34. Mountain Studies Institute Note: 2002 - 2014 data is River Watch data from the Animas River at the fish hatchery in Durango, CO. 2015 data is Mountain Studies Institute data from the Animas River at Rotary Park in Durango, CO SAN JUAN MOUNTAINS, CO

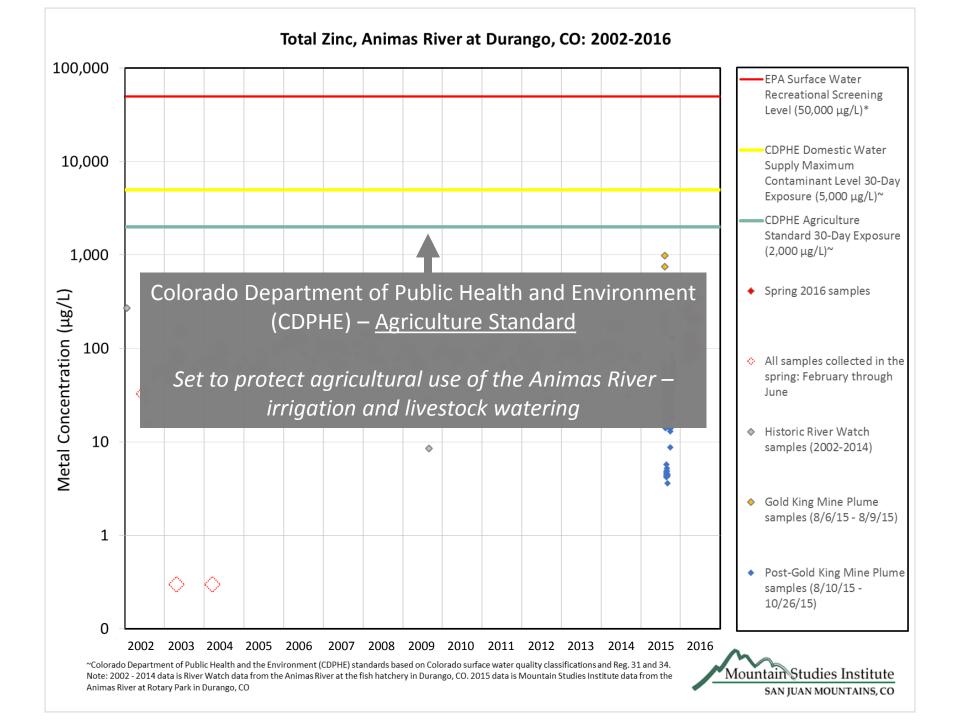
Total Zinc, Animas River at Durango, CO: 2002-2016 100,000 EPA Surface Water Recreational Screening Level (50,000 μg/L)* CDPHE Domestic Water 10,000 Supply Maximum Contaminant Level 30-Day Exposure (5,000 µg/L)~ CDPHE Agriculture Standard 30-Day Exposure $(2,000 \mu g/L)^{\sim}$ 1,000 Spring 2016 samples Metal Concentration (μg/L) 100 All samples collected in the spring: February through June Historic River Watch 10 samples (2002-2014) So far this spring, zinc concentrations have been at levels considered safe for Recreation, Agriculture, and Drinking ♦ Gold King Mine Plume Water Supply (below water quality benchmarks). samples (8/6/15 - 8/9/15) Post-Gold King Mine Plume samples (8/10/15 -10/26/15) 0 2006 2007 2008 2009 2016 ~Colorado Department of Public Health and the Environment (CDPHE) standards based on Colorado surface water quality classifications and Reg. 31 and 34.

Note: 2002 - 2014 data is River Watch data from the Animas River at the fish hatchery in Durango, CO. 2015 data is Mountain Studies Institute data from the Animas River at Rotary Park in Durango, CO

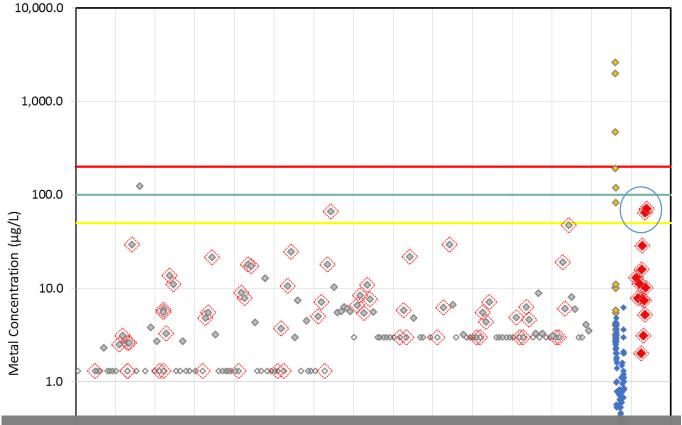
Total Lead, Animas River at Durango, CO: 2002-2016

Although most samples indicate that lead concentrations were at levels considered safe for use as a drinking water supply, samples from May 6 and May 22 had lead levels that were below the water quality standard for domestic drinking water supply. However, the City of Durango does not source drinking water from the Animas River during spring runoff and treated city water meets all drinking water standards.

- EPA Surface Water
 Recreational Screening Level
 (200 μg/L)*
- CDPHE Agriculture Standard 30-Day Exposure (100 µg/L)~
- —CDPHE Domestic Water Supply Maximum Contaminant Level 1-Day Exposure (50 µg/L)∼
- Spring 2016 samples
- All samples collected in the spring: February through June
- Historic River Watch samples (2002-2014)
- Gold King Mine Plume samples (8/6/15 - 8/9/15)
- Post-Gold King Mine Plume samples (8/10/15 - 10/26/15)
- Samples with concentrations below Method Detection Limit

Manganese and lead surpassed CDPHE Domestic Drinking Water Quality Standards during spring runoff.

- City of Durango does not source drinking water from the Animas River during Spring Runoff
- When the City of Durango does source drinking water from the Animas River, water is thoroughly treated and meets all water quality regulations.
- Manganese at this level is not of concern for human health.
 The concern is associated with aesthetic effects, such as staining of appliances.

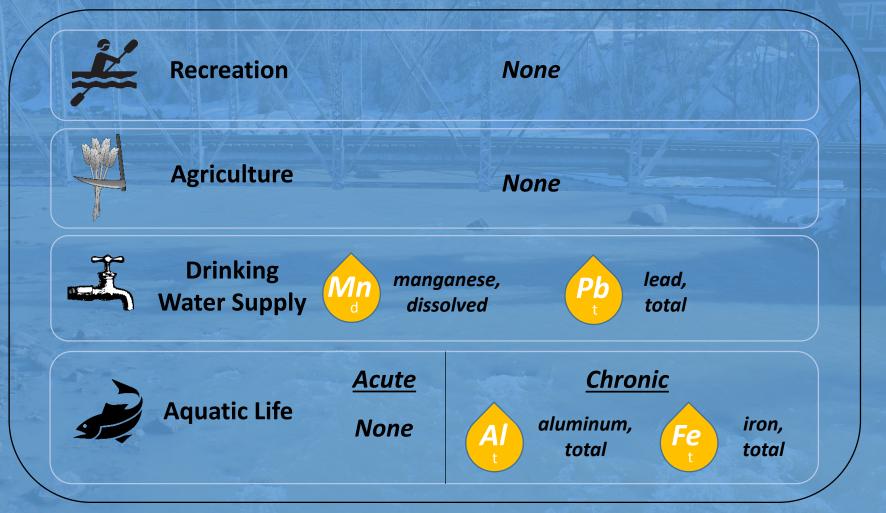
So far, have metals during spring runoff been higher than water quality benchmarks?

Note: t=total recoverable; d=dissolved

So far, the Animas River has contained low levels of metals during spring runoff.

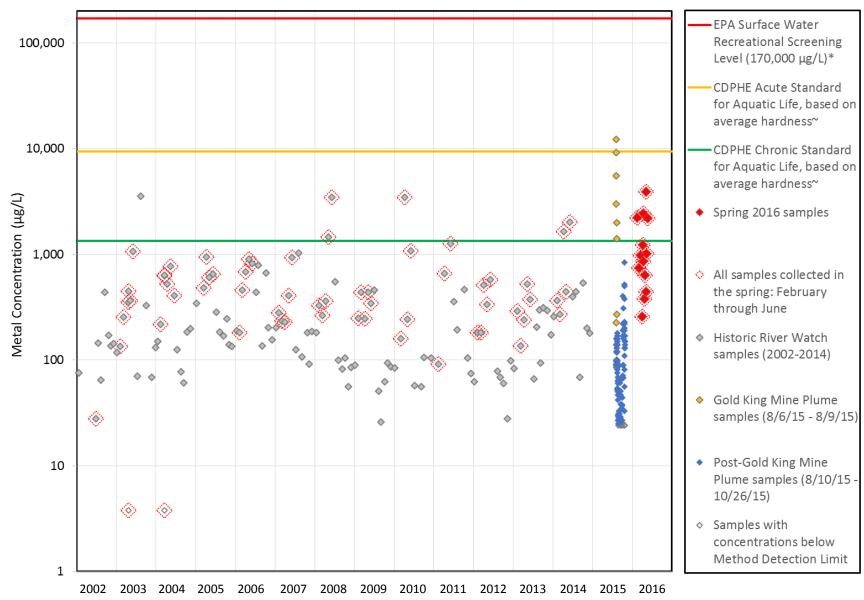
Total Aluminum, Animas River at Durango, CO: 2002-2016

^{*} The recreational screening level represents the level at which no adverse health effects are expected to occur in humans consuming 2L of water per day, from the Animas, orally, for 64 days each year for a total of 30 years.
*Colorado Department of Public Health and the Environment (CDPHE) standards based on Colorado surface water quality classifications and Reg. 31 and 34. Standards vary with water hardnesss and are plotted here using an average water hardness of the Animas River at this location, 208 mg/L.

Note: 2002 - 2014 data is River Watch data from the Animas River at the fish hatchery in Durango, CO. 2015 and 2016 data is Mountain Studies Institute data from the Animas River at Rotary Park in Durango, CO

Aluminum and iron surpassed CDPHE Chronic Standards for Aquatic Life during spring runoff. High levels of aluminum and iron are not unprecedented, they have occurred during spring runoff in previous years.

It is important to note that there are large natural sources of aluminum and iron in the Animas River watershed that are not related to mining activities.

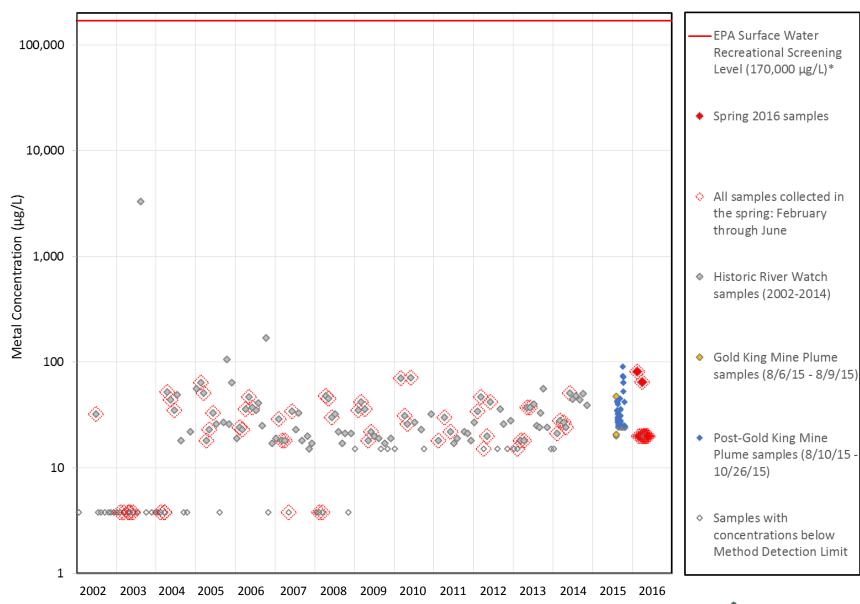
Dissolved Aluminum, Animas River at Durango, CO: 2002-2016

^{*} The recreational screening level represents the level at which no adverse health effects are expected to occur in humans consuming 2L of water per day, from the Animas, orally, for 64 days each year for a total of 30 years.

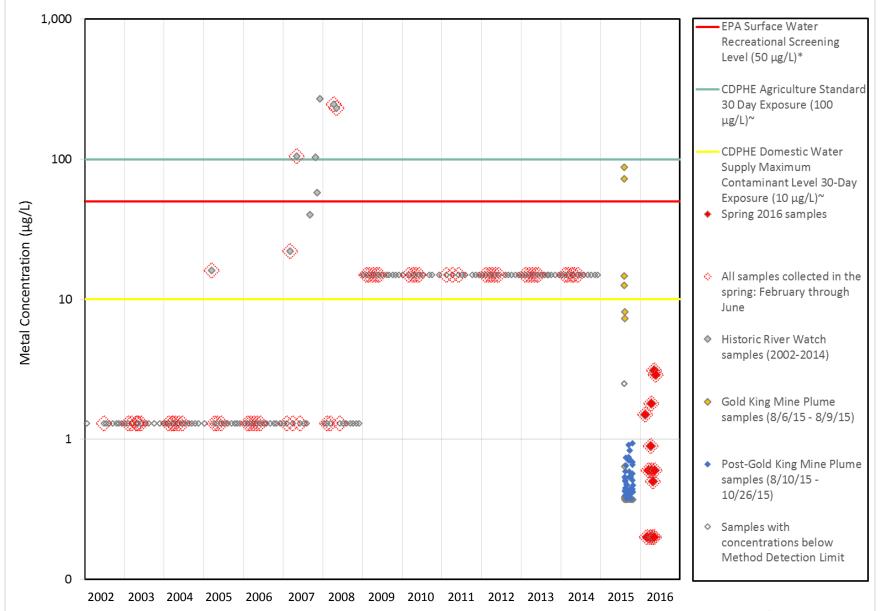
Total Arsenic, Animas River at Durango, CO: 2002-2016

^{*} The recreational screening level represents the level at which no adverse health effects are expected to occur in humans consuming 2L of water per day, from the Animas, orally, for 64 days each year for a total of 30 years

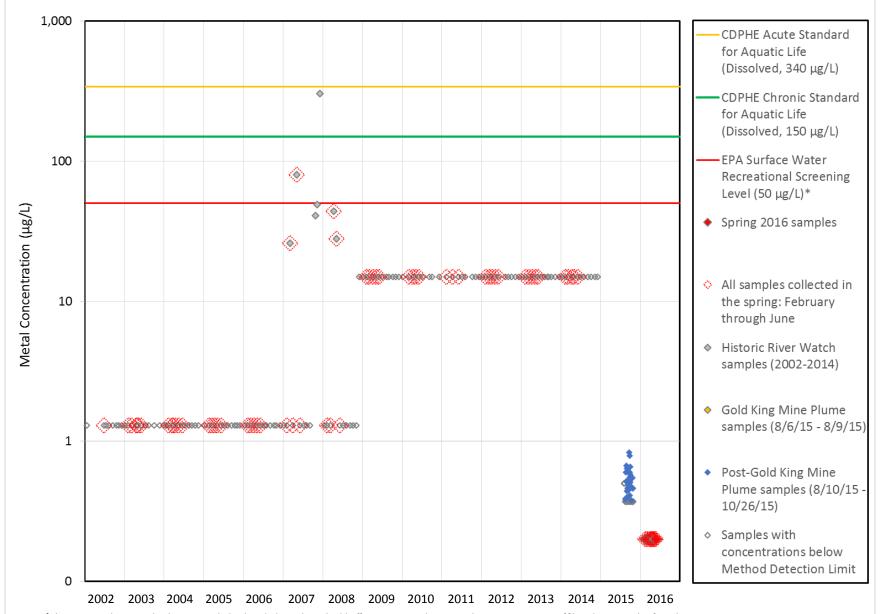
Dissolved Arsenic, Animas River at Durango, CO: 2002-2016

^{*} The recreational screening level represents the level at which no adverse health effects are expected to occur in humans consuming 2L of filtered water per day, from the Animas, orally, for 64 days each year for a total of 30 years.

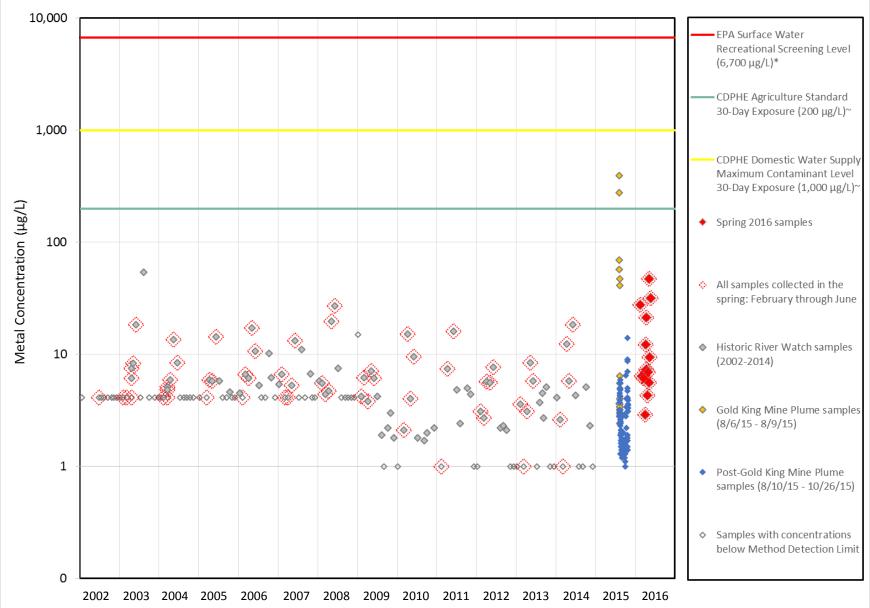
Total Copper, Animas River at Durango, CO: 2002-2016

^{*}The recreational screening level represents the level at which no adverse health effects are expected to occur in humans consuming 2L of water per day, from the Animas, orally, for 64 days each year for a total of 30 years.
*Colorado Department of Public Health and the Environment (CDPHE) standards based on Colorado surface water quality classifications and Reg. 31 and 34.

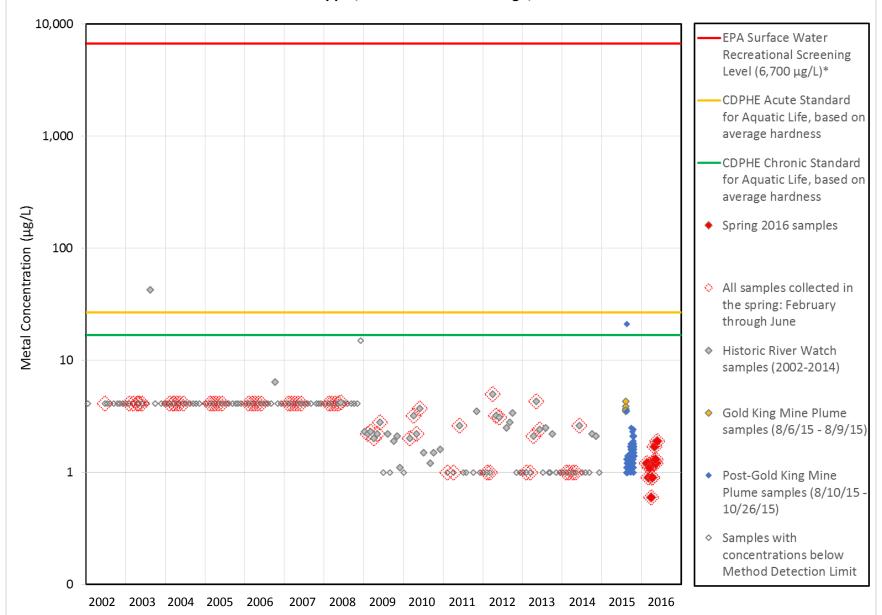
Dissolved Copper, Animas River at Durango, CO: 2002-2016

^{*} The recreational screening level represents the level at which no adverse health effects are expected to occur in humans consuming 2L of water per day, from the Animas, orally, for 64 days each year for a total of 30 years.

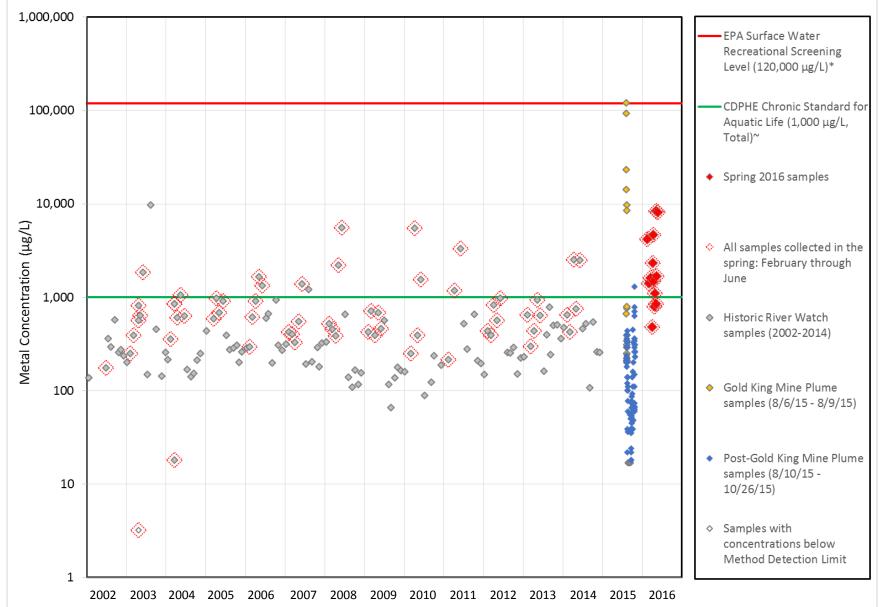
Total Iron, Animas River at Durango, CO: 2002-2016

^{*} The recreational screening level represents the level at which no adverse health effects are expected to occur in humans consuming 2L of filtered water per day, from the Animas, orally, for 64 days each year for a total of 30 years.

[~]Colorado Department of Public Health and the Environment (CDPHE) standards based on Colorado surface water quality classifications and Reg. 31 and 34.

Note: 2002 - 2014 data is River Watch data from the Animas River at the fish hatchery in Durango, CO. 2015 and 2016 data is Mountain Studies Institutedata from the Animas River at Rotary Park in Durango, CO.

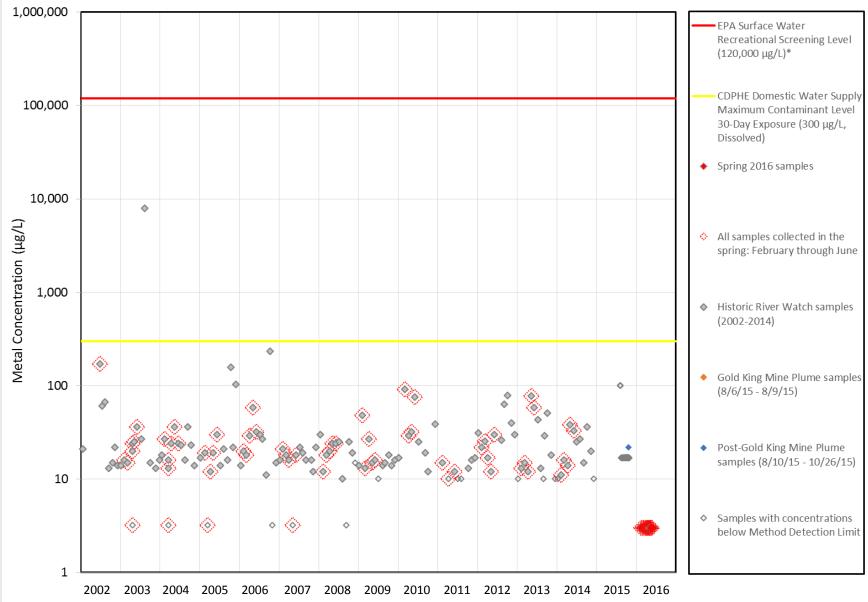
Dissolved Iron, Animas River at Durango, CO: 2002-2016

^{*} The recreational screening level represents the level at which no adverse health effects are expected to occur in humans consuming 2L of filtered water per day, from the Animas, orally, for 64 days each year for a total of 30 years.

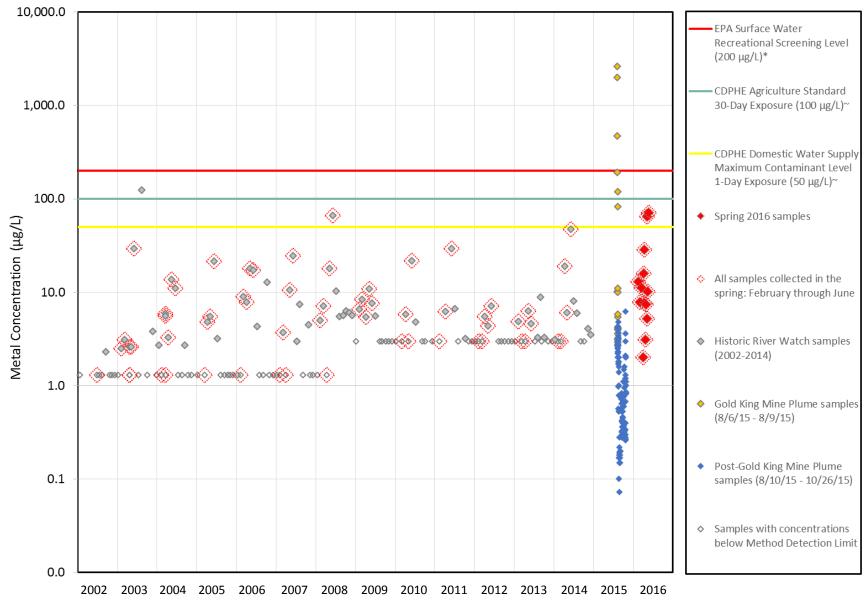
Total Lead, Animas River at Durango, CO: 2002-2016

^{*}The recreational screening level represents the level at which no adverse health effects are expected to occur in humans consuming 2L of water per day, from the Animas, orally, for 64 days each year for a total of 30 years.

"Colorado Department of Public Health and the Environment (CDPHE) standards based on Colorado surface water quality classifications and Reg. 31 and 34.

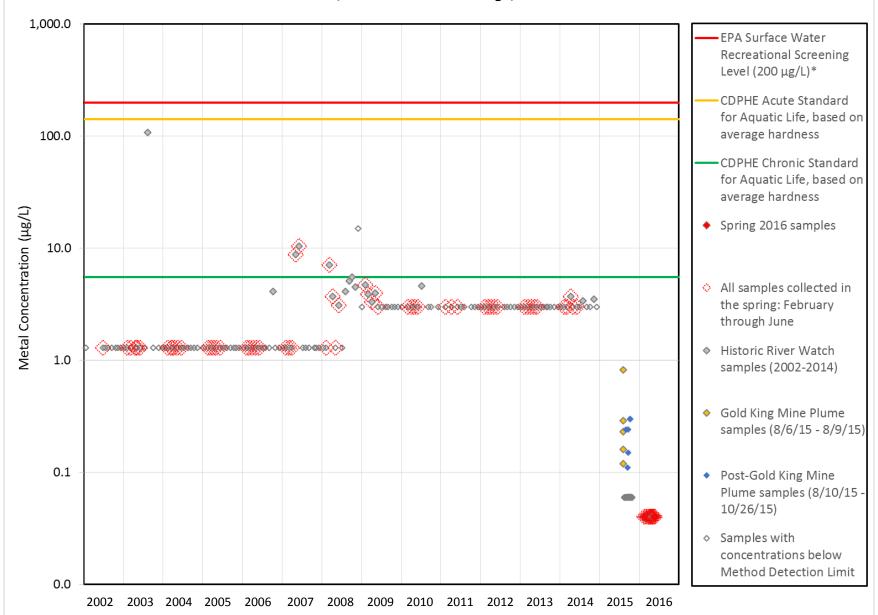
Dissolved Lead, Animas River at Durango, CO: 2002-2016

^{*} The recreational screening level represents the level at which no adverse health effects are expected to occur in humans consuming 2L of filtered water per day, from the Animas, orally, for 64 days each year for a total of 30 years.

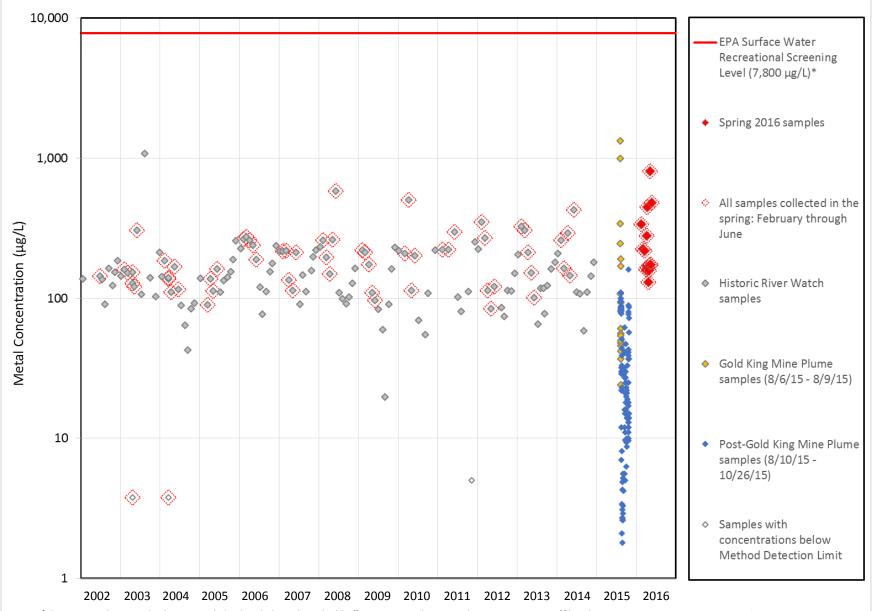
Total Manganese, Animas River at Durango, CO: 2002-2016

^{*} The recreational screening level represents the level at which no adverse health effects are expected to occur in humans consuming 2L of filtered water per day, from the Animas, orally, for 64 days each year for a total of 30 years.

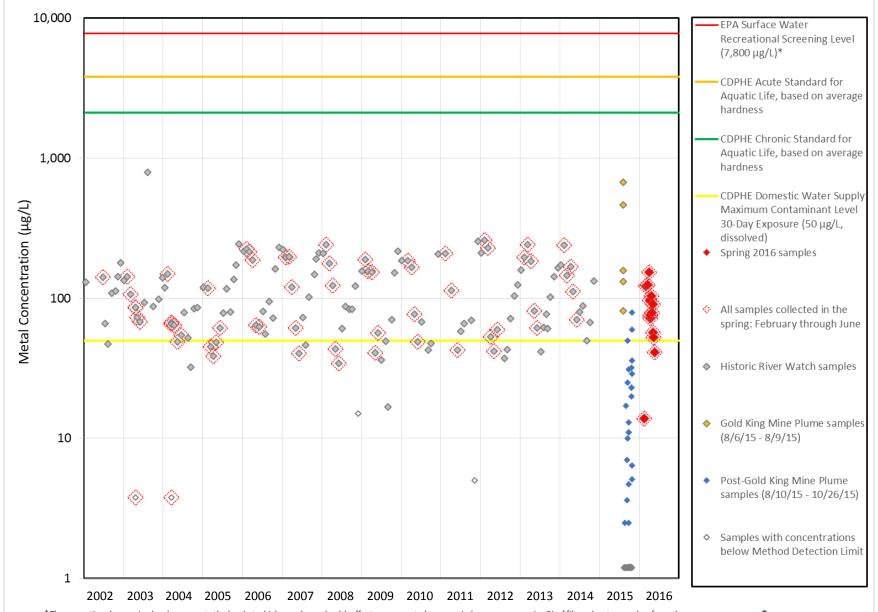
Dissolved Manganese, Animas River at Durango, CO: 2002-2016

^{*} The recreational screening level represents the level at which no adverse health effects are expected to occur in humans consuming 2L of filtered water per day, from the Animas, orally, for 64 days each year for a total of 30 years.

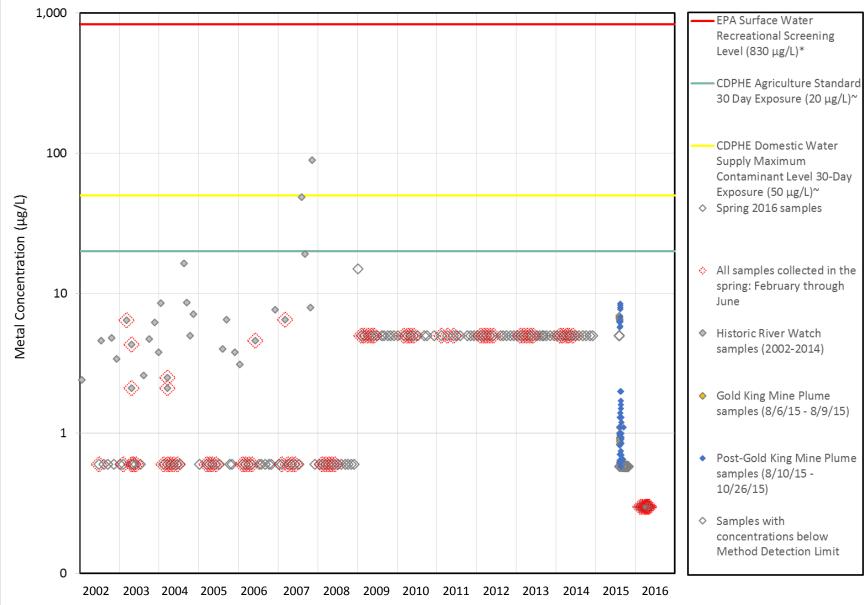
Total Selenium, Animas River at Durango, CO: 2002-2016

^{*}The recreational screening level represents the level at which no adverse health effects are expected to occur in humans consuming 2L of filtered water per day, from the Animas, orally, for 64 days each year for a total of 30 years.

*Colorado Department of Public Health and the Environment (CDPHE) standards based on Colorado surface water quality classifications and Reg. 31 and 34.

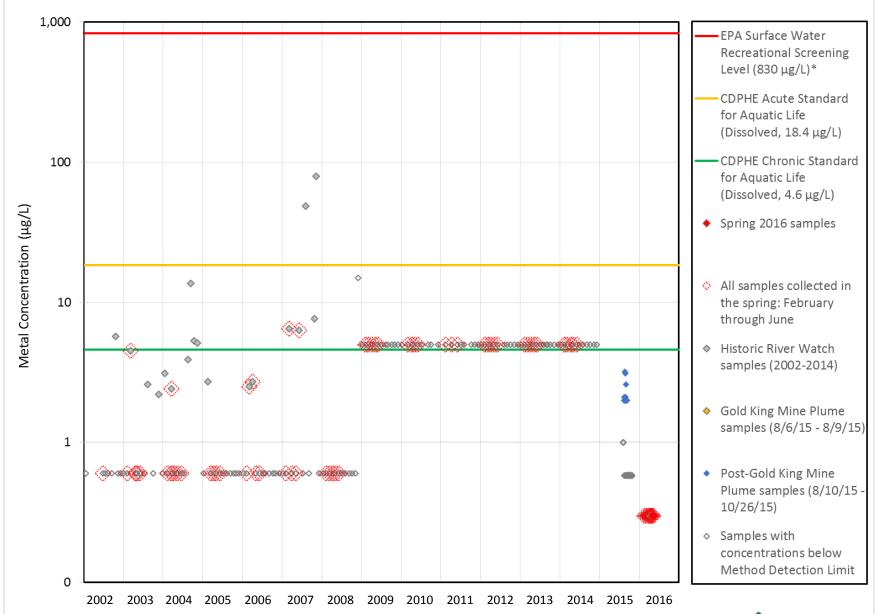
Dissolved Selenium, Animas River at Durango, CO: 2002-2016

^{*} The recreational screening level represents the level at which no adverse health effects are expected to occur in humans consuming 2L of filtered water per day, from the Animas, orally, for 64 days each year for a total of 30 years.

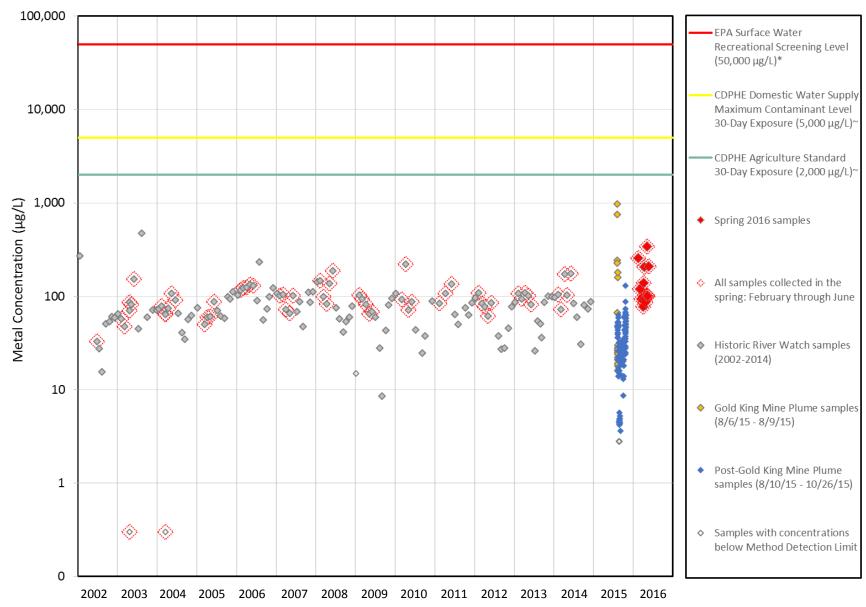
Total Zinc, Animas River at Durango, CO: 2002-2016

^{*}The recreational screening level represents the level at which no adverse health effects are expected to occur in humans consuming 2L of water per day, from the Animas, orally, for 64 days each year for a total of 30 years.
*Colorado Department of Public Health and the Environment (CDPHE) standards based on Colorado surface water quality classifications and Reg. 31 and 34.

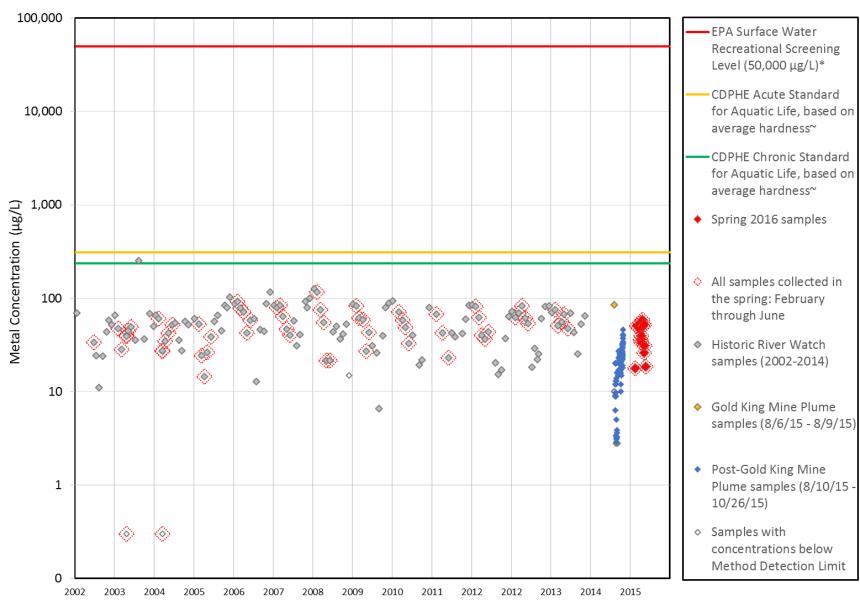
Dissolved Zinc, Animas River at Durango, CO: 2002-2016

^{*}The recreational screening level represents the level at which no adverse health effects are expected to occur in humans consuming 2L of water per day, from the Animas, orally, for 64 days each year for a total of 30 years. *Colorado Department of Public Health and the Environment (CDPHE) standards based on Colorado surface water quality classifications and Reg. 31 and 34. Standards vary with water hardness and are plotted here using

an average water hardness of the Animas River at this location, 208 mg/L.

Note: 2002 - 2014 data is River Watch data from the Animas River at the fish hatchery in Durango, CO. 2015 and 2016 data is Mountain Studies Institute data from the Animas River at Rotary Park in Durango, CO
